Eklutna Hydroelectric Project

Lakeside Trail Erosion Study

Study Report

Prepared by:
Kathy Vanderwal Dubé
Watershed GeoDynamics

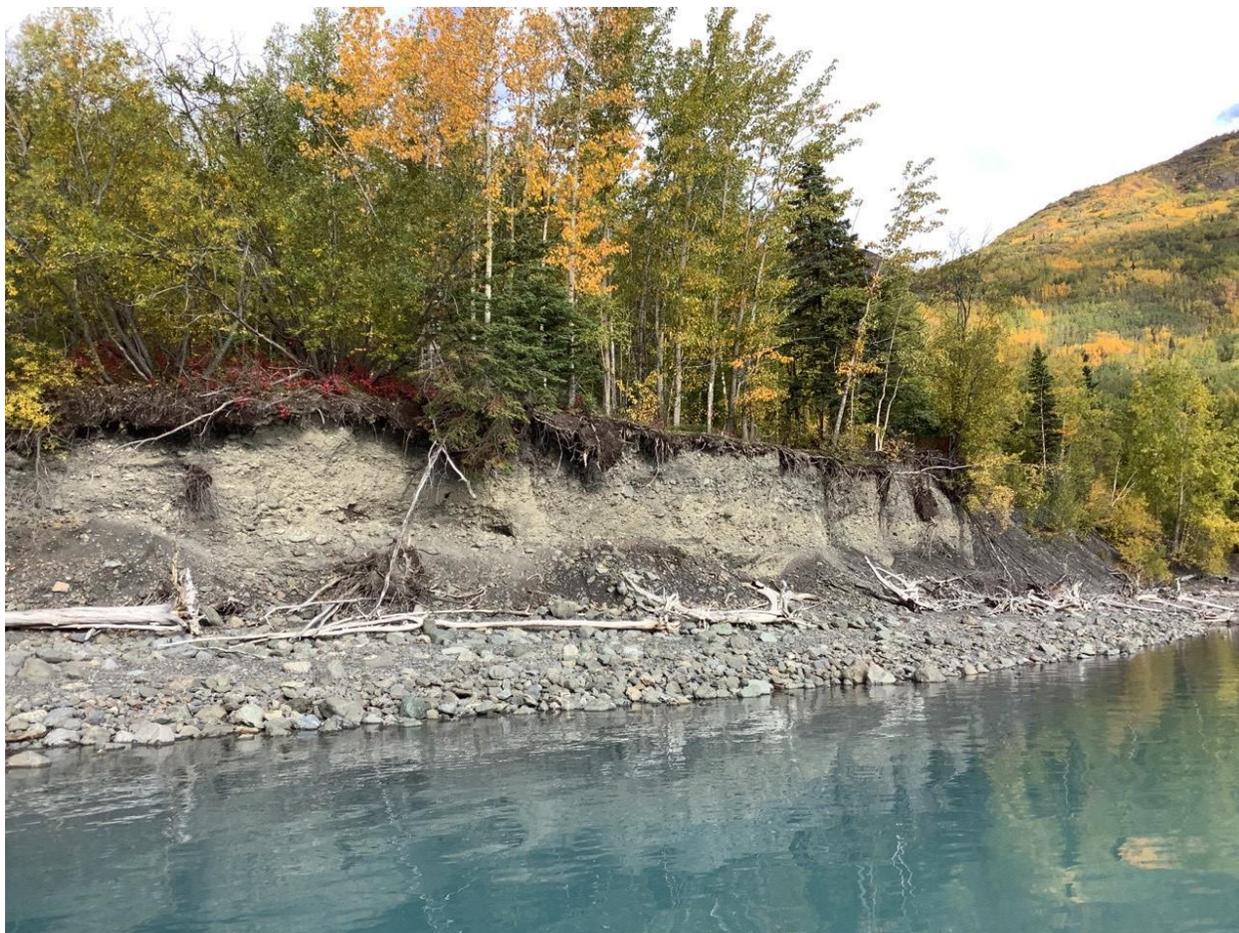
Undercut banks occur in areas where soil is relatively consolidated and can stand in steep, near vertical banks when eroded (Figure 5.2-1). On Eklutna Lake, wave action at high lake elevations erodes material along the base of these banks which results in an undercut bank. The undercutting continues until the weight of the overlying material exceeds the strength of the bank and the overlying material topples or slides. The process repeats causing the bank to retreat away from the lake and resulting in a higher and higher bank. In some places vegetation provides additional strength to the top layers of soil and can result in an overhanging mat of vegetation or roots.

Figure 5.2-1. Undercut bank formed by wave action.

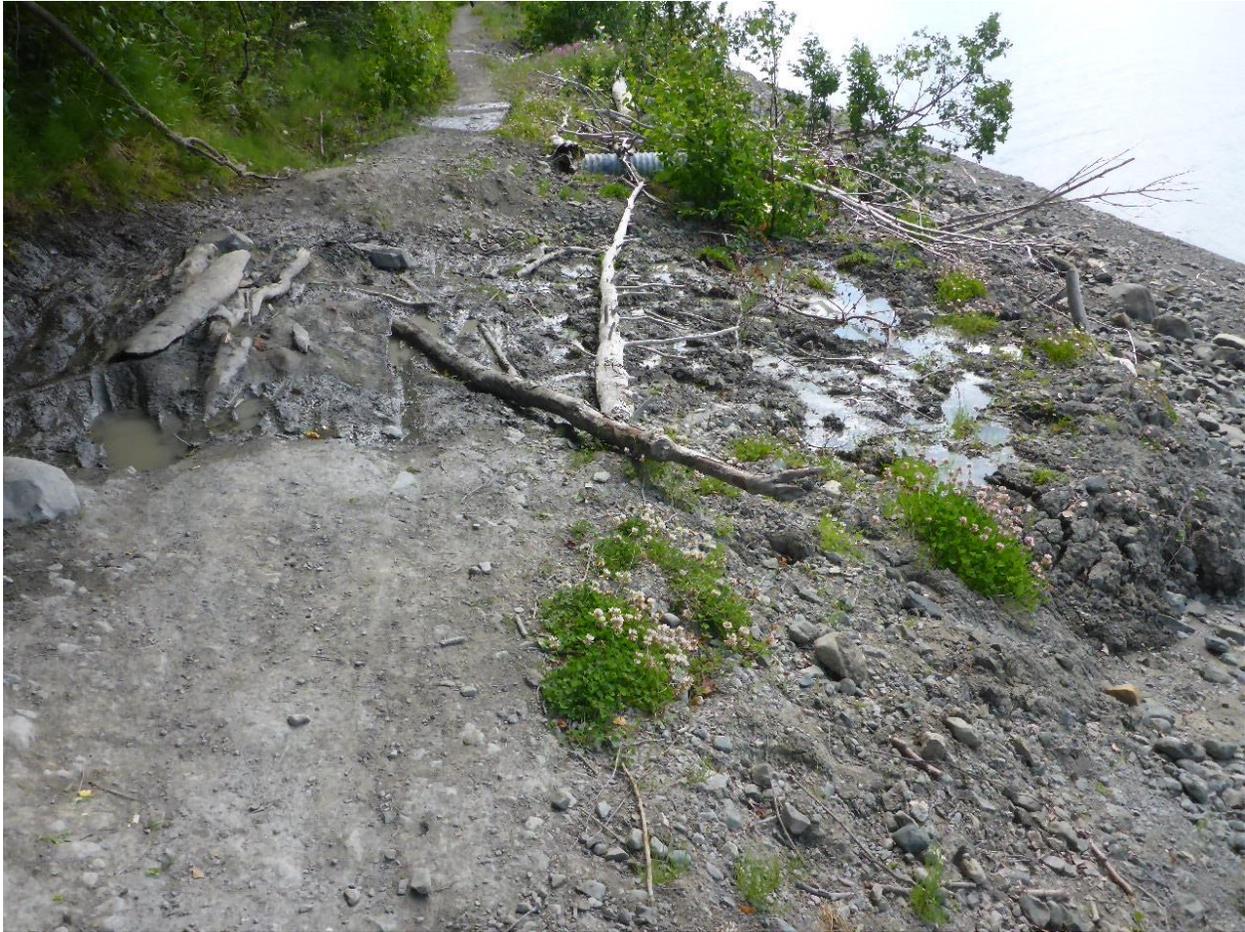
Hillside drainage, blocked culverts, and groundwater seepage along some parts of the trail cause the soil to become saturated and cause earthflows or slumping of bank material. Drainage issues are most pronounced in valley wall landforms on the southeastern (upstream) third of the Lakeside Trail. Several fully or partially blocked culverts and ditches were noted during the field inventory, as well as areas with no drainage structures, that caused runoff and saturation of the trail surface. In areas where underlying soil strength was low or where waves had caused a steep bank, slumping and earthflows occurred on the bank (Figures 5.2-2 and 5.2-3).

Figure 5.2-2. Drainage issue leading to saturated trail surface and earthflow.

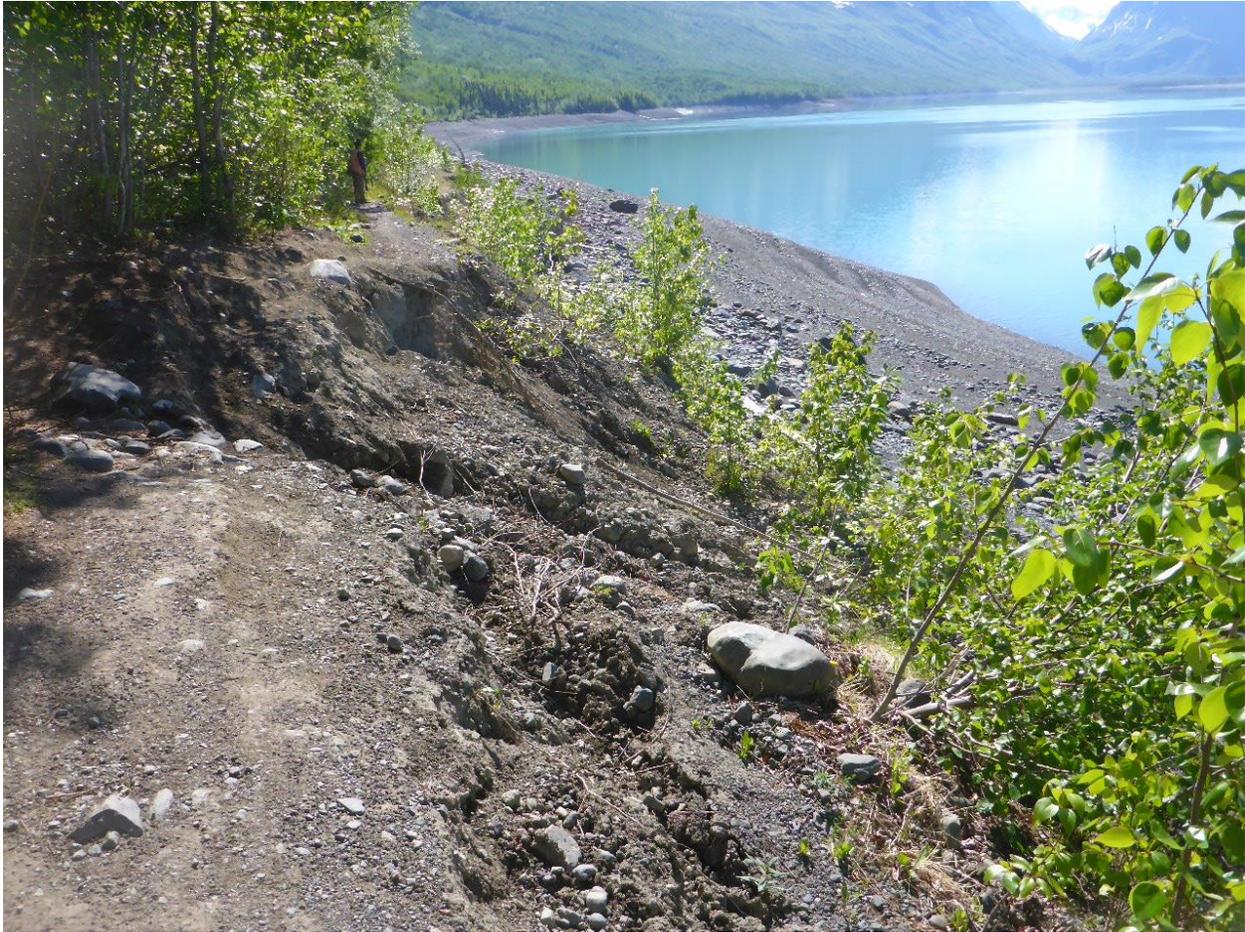
Figure 5.2-3. Drainage issue leading to slumping along trail.

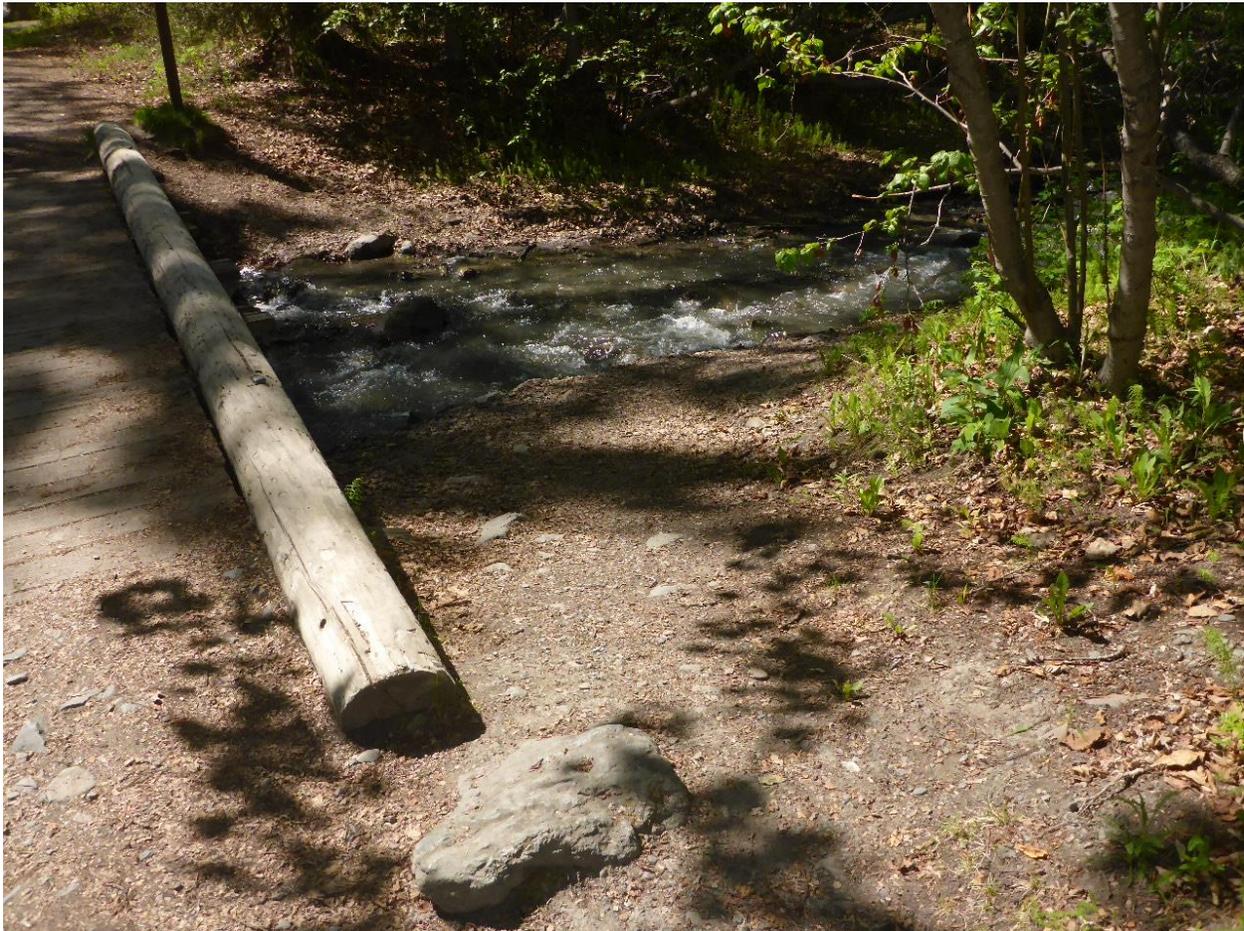
People recreating along lakes and streams like to access the water using formal access points in designated areas or informal access points in dispersed use areas. Informal access points often result in trampling of riparian vegetation near bridges and lakeside trails, killing vegetation that protects soil from erosion and reducing infiltration capacity due to compaction (Figure 5.2-4). Surface erosion and rills often form in trampled areas from trail runoff.

Figure 5.2-4. Trampling adjacent to Lach Oahu Creek bridge resulting in loss of riparian vegetation and surface erosion.

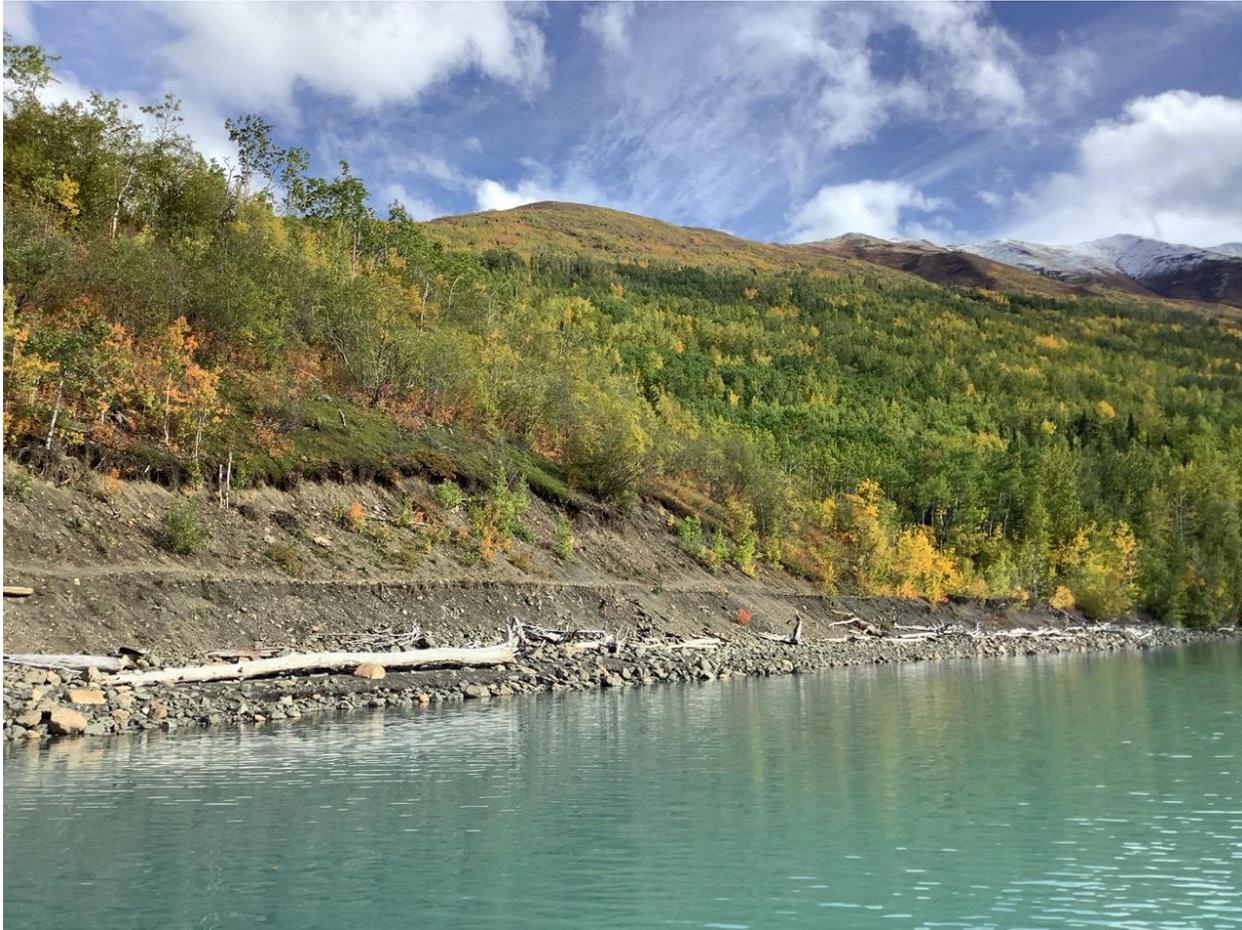
Raveling is a loose, grain-by-grain movement of material down a steep slope that often occurs in unconsolidated material when vegetation or cover is removed. Raveling of colluvium and glacial deposits was observed on unvegetated cutslopes and fillslopes at several locations along the shoreline trail (Figure 5.2-5).

Figure 5.2-5. Raveling cutslopes and bank.

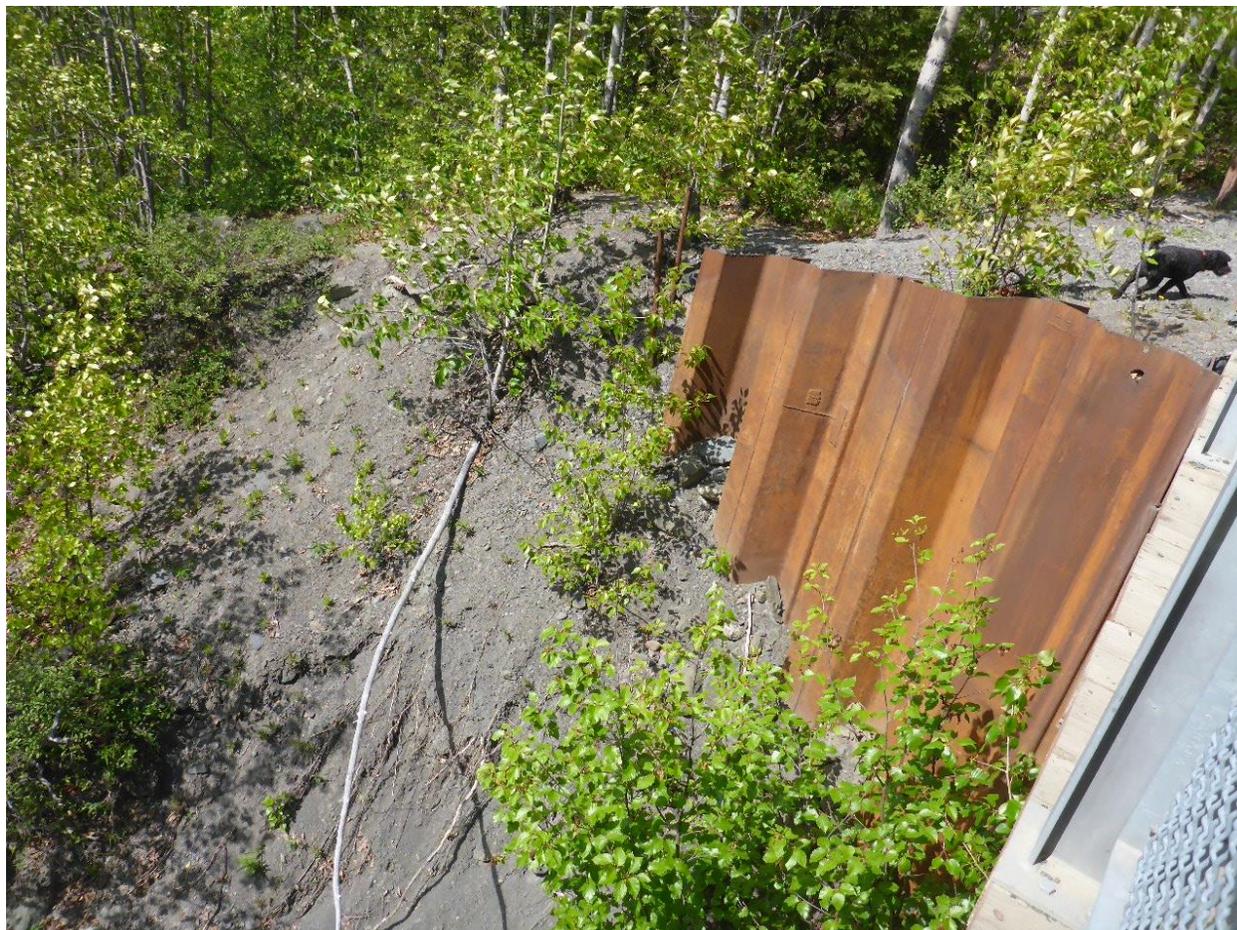
Streambank erosion is the result of moving water at high streamflows acting on unvegetated banks. Streambank erosion was noted near the Bold Creek Bridge footings (Figure 5.2-6).

Figure 5.2-6. Streambank erosion at Bold Creek Bridge.

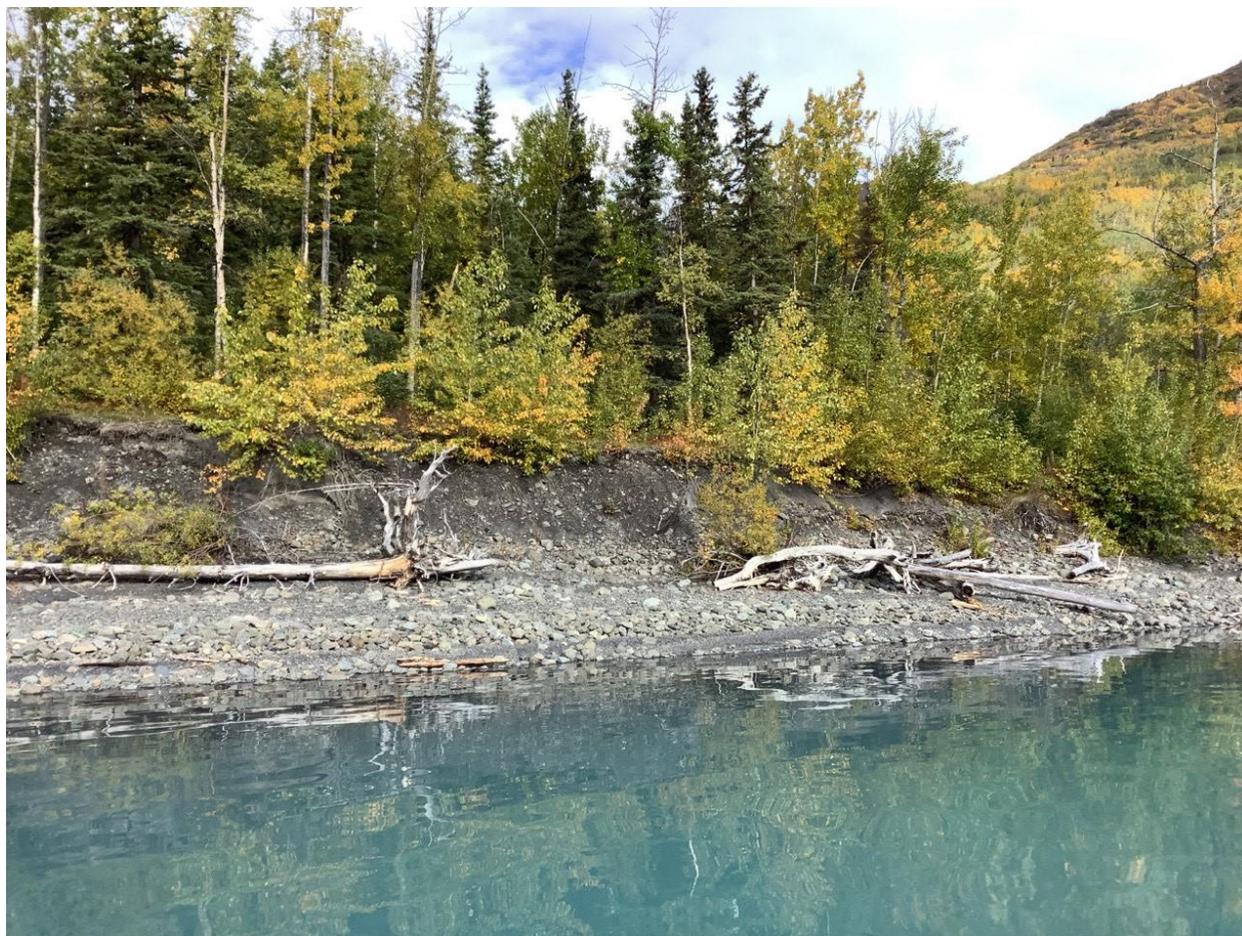
The Yuditna Public Use cabin is located on the northern shore of Eklutna Lake on a side access trail approximately 3 miles from the trailhead. The access trail to the cabin (erosion site E12) has approximately 300 feet of undercut/raveling bank with a bank height of 10-11 feet (Figure 5.3-4). Chugach State Park staff have installed jute mats, coir rolls, and vegetation (grass seeding) as erosion control measures along this bank. The measures are effective in slowing erosion in some spots, but erosion is continuing in other sections.

Figure 5.3-4. Trail to Yuditna Public Use Cabin.

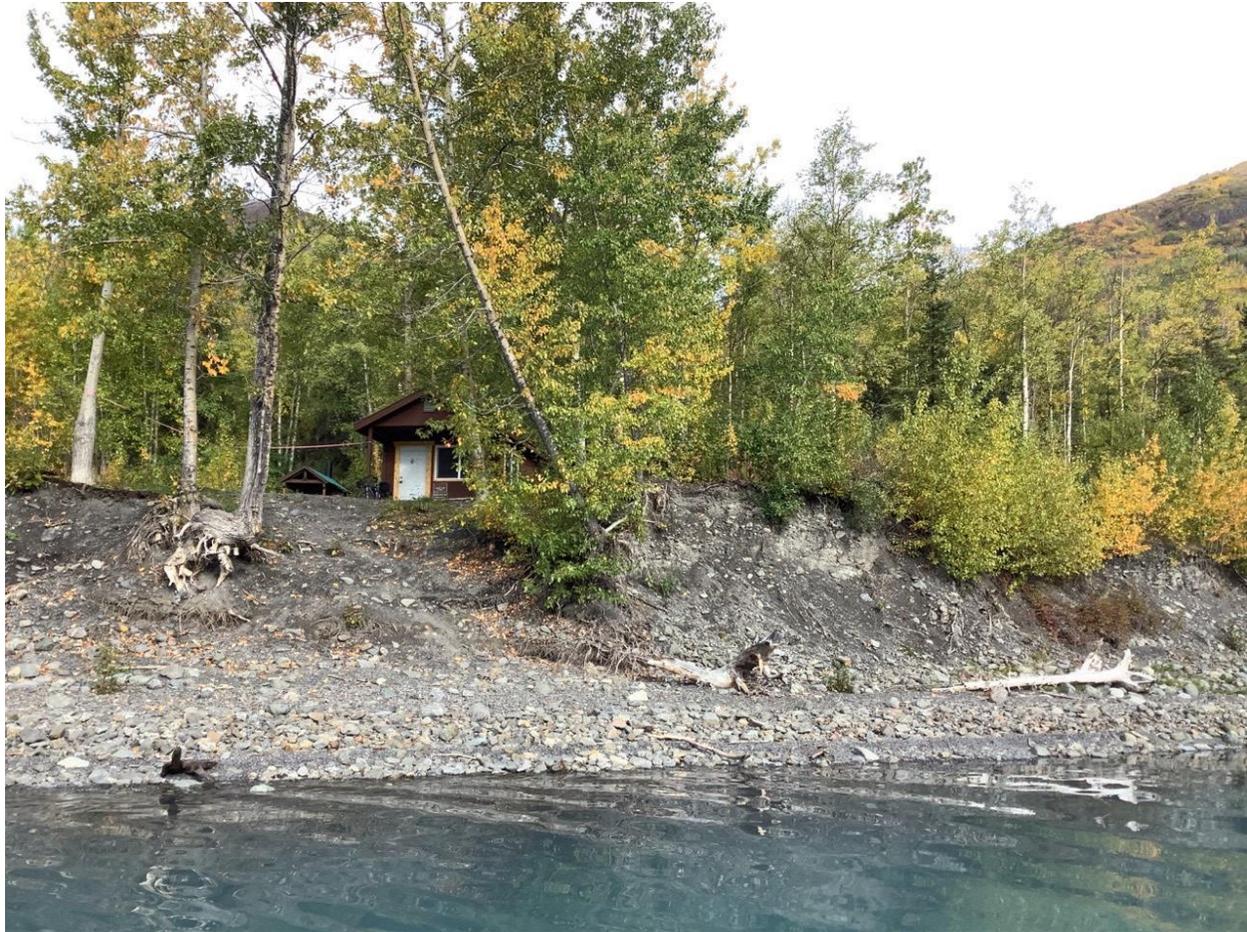
The Yuditna Cabin is located on a point, the outer edge of the Yuditna Creek alluvial fan and set back from the lake bluff (Figure 5.3-5). Cabin visitors have made an informal path down the bluff to the lake. Trampling as well as wave action result in erosion on the shoreline near the cabin.

Figure 5.3-5. Yuditna Public Use Cabin shoreline.

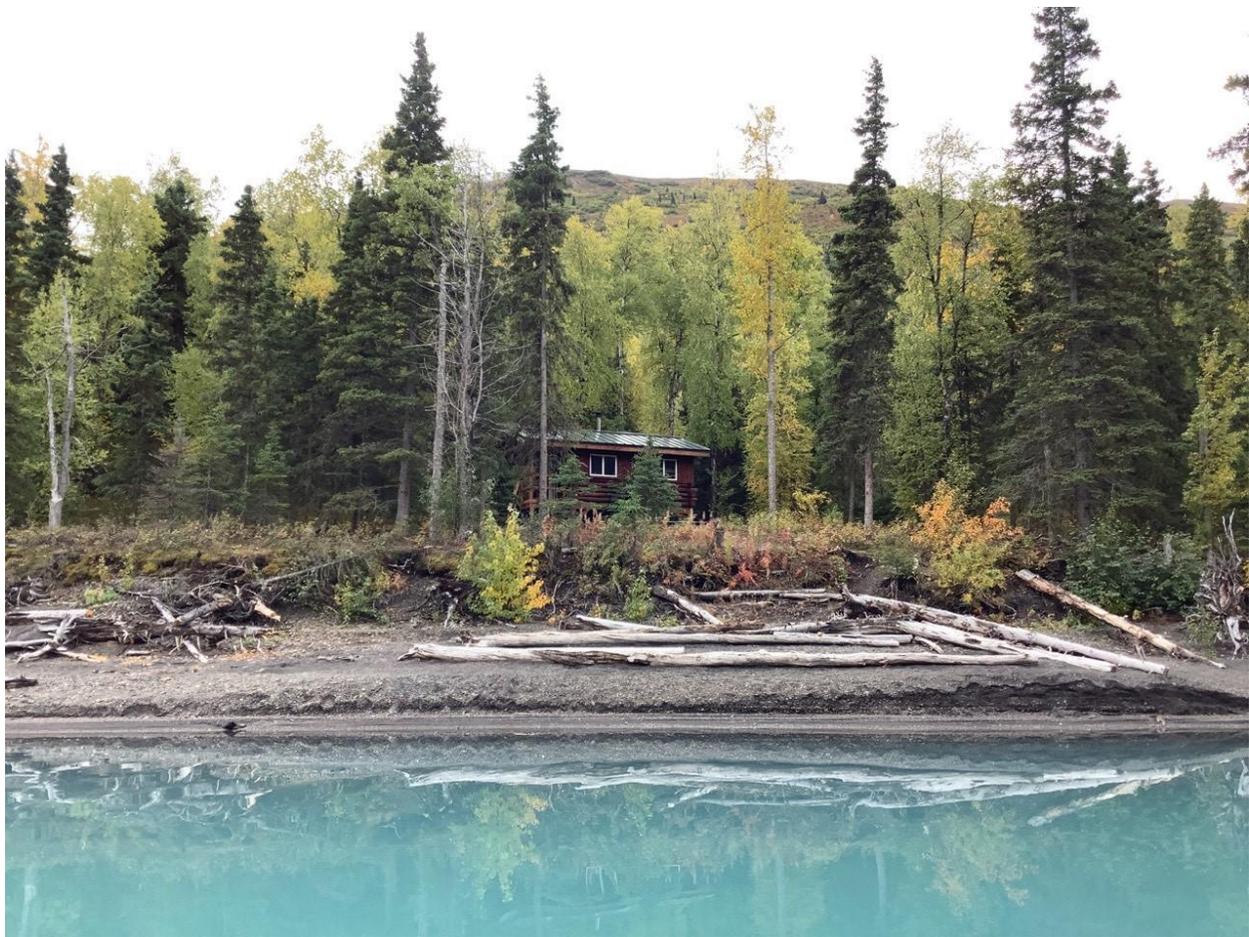
The Kokanee Public Use Cabin is located on the south side of Eklutna Lake and is only accessible by boat. The cabin was constructed four years ago and is set back from the shoreline (Figure 5.3-6). The shore near the Kokanee Cabin is approximately 4-5 feet high, partially vegetated and relatively stable, with some evidence of past erosion. The beach near the cabin is lower gradient and has several large logs; both these conditions reduce wave energy on the base of the bank.

Figure 5.3-6. Kokanee Public Use Cabin

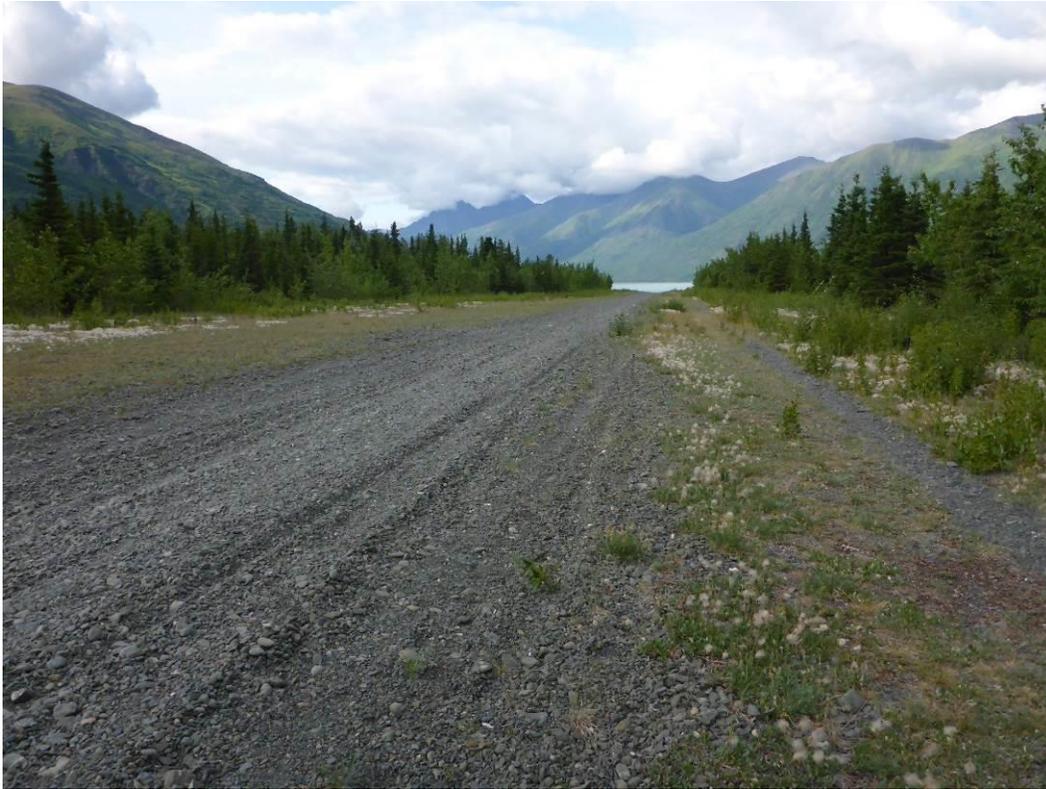
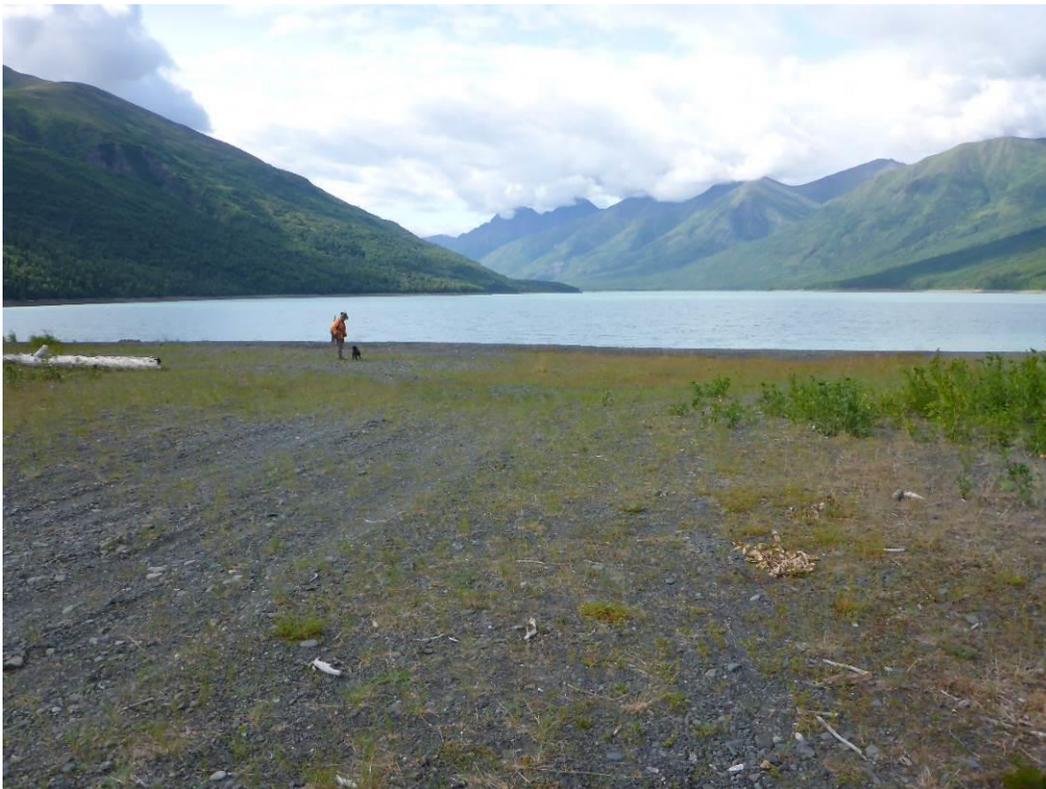
The Bold Airstrip is located at the upper end of Eklutna Lake. The airstrip was constructed in summer 1962 based on historical aerial photographs (there may have been an informal airstrip at this location earlier than 1962). No major erosion was noted at the lake shore end of the airstrip. The lake end of the airstrip is reported to be inundated at high lake levels. Based on the 2020 LiDAR map, approximately 200 feet of the runway is below elevation 871 feet (msl, NGVD29) which corresponds to the crest of the Eklutna Lake Dam spillway and approximately 70 percent of the runway length is below elevation 877 feet, the highest lake elevation recorded since 1965.

Figure 5.3-7. Bold Airstrip (top) and lakeshore at end of airstrip (bottom)

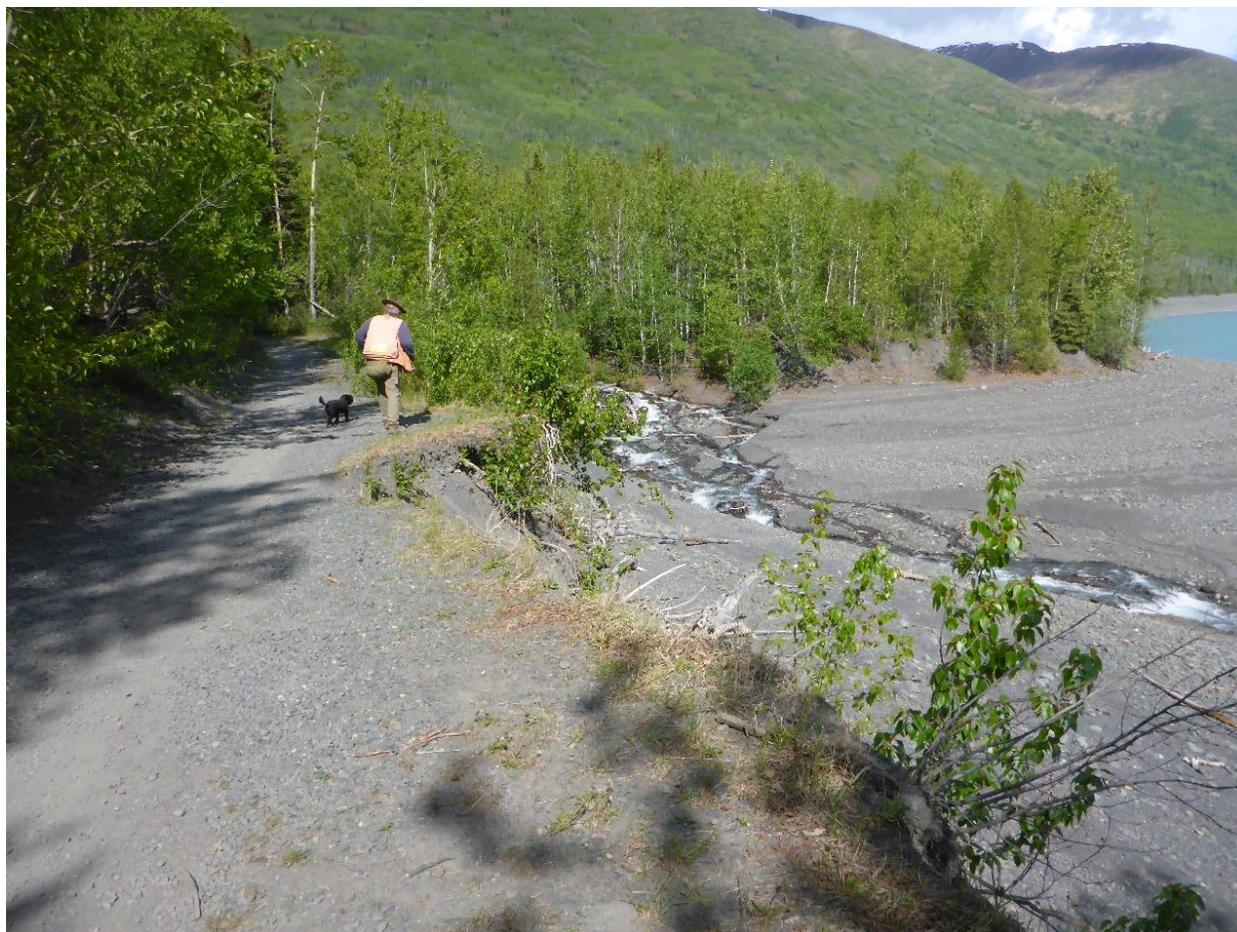
Figure 5.4-1. Erosion site E10.

Both Sites E10 and E11 include areas where the non-motorized trail is very narrow with a steep drop adjacent to the trail (7 to 20 feet drop; Figures 5.4-1 and 5.4-2). The approach to both of these areas is relatively steep, and the narrow portion of the trail is at a bend in the trail so the narrow areas are not visible from far away. These areas could be a hazard to bike riders since bikes travel faster than pedestrians. Signs to indicate narrow trail conditions could help remind bike riders to slow down at these locations.

The primary factor contributing to erosion at both of these locations is wave action. Pedestrian traffic to access the beach noted at site E10 is also contributing to bank erosion. At site E11, runoff from trail drainage is contributing to bank erosion by creating rills down the bank.

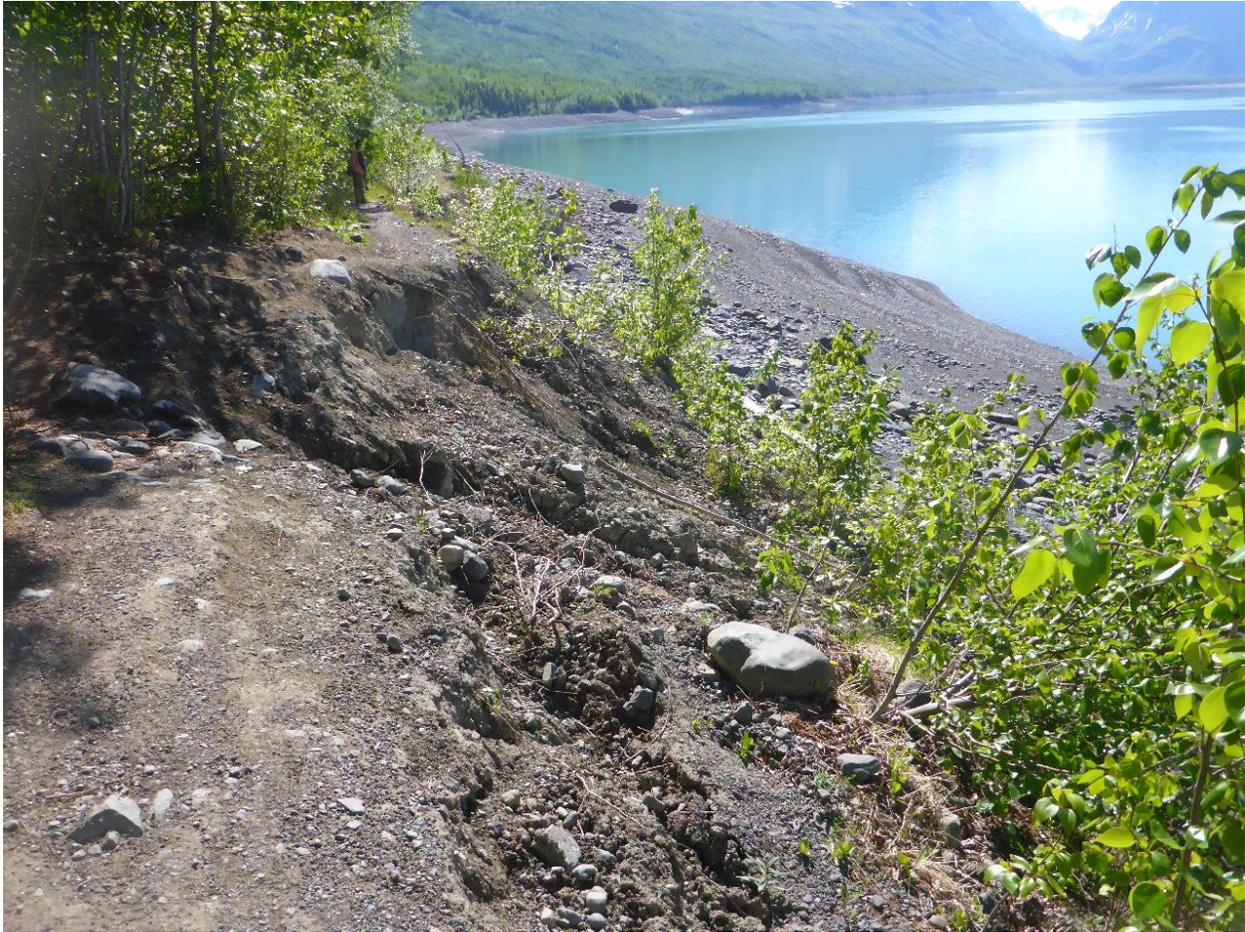
Figure 5.4-3. Erosion site E14.

Erosion site E14 is an area of undercut bank and slumping of the bank that has resulted in loss of the entire width of the trail at one location (Figure 5.4-3). This site is within a much larger, older slumped area of the hillside (see landform map, Figure 5.3-2 and Figure 5.4-4) and is in an inherently unstable area with seepage and saturated soil conditions. Seepage from the cutslope saturates the trailbed and results in washout and slumping of the trail at this location. In addition, wave action has undercut the toe of the bank on either side of the washout section. The bank is 14 feet high and difficult to cross on foot or bike. This site could benefit from drainage structures that help to dewater the area and erosion control at the base of the slope to minimize wave erosion and allow a wider trail.

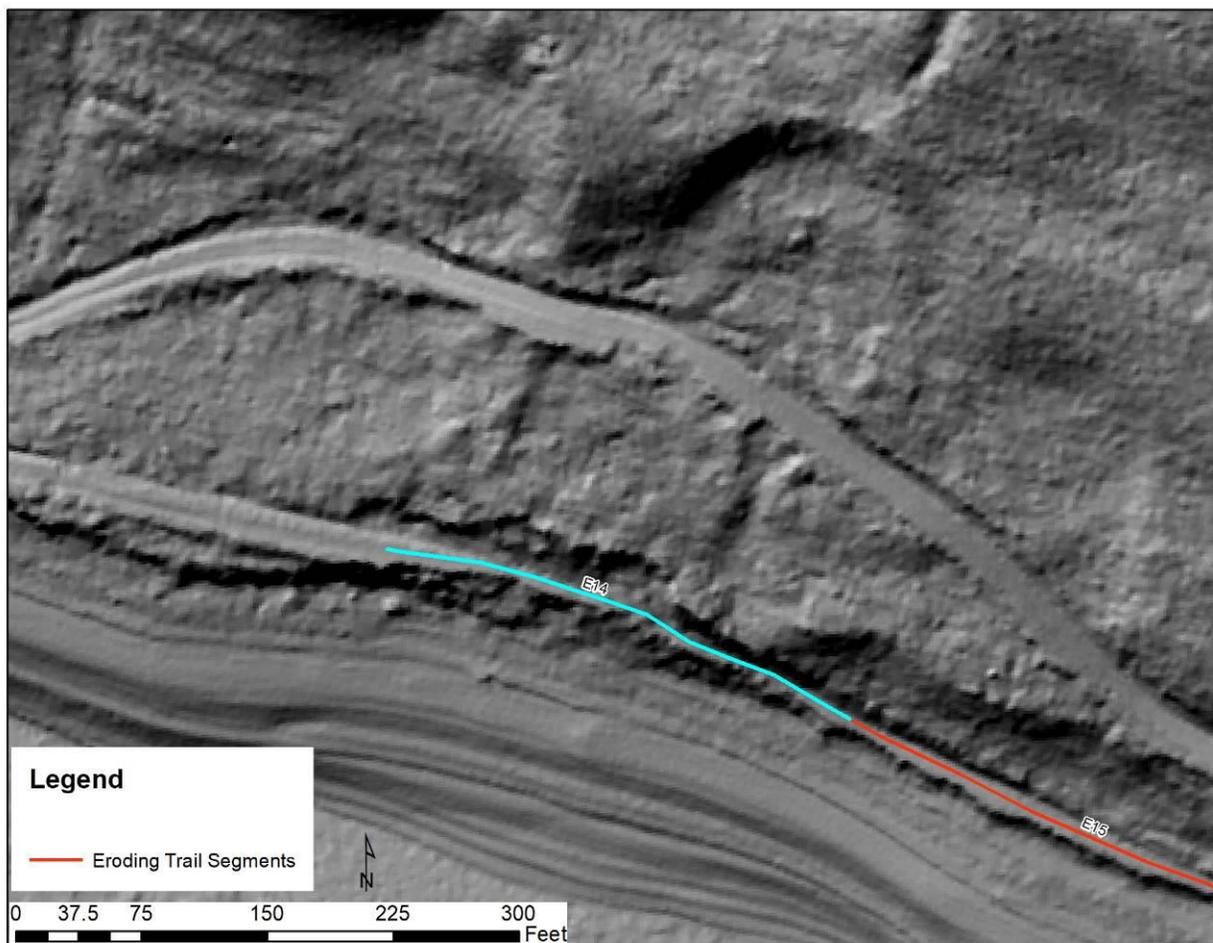
Figure 5.4-4. Erosion site E14 map showing larger, old slump feature upslope from the trail erosion site.⁴

⁴ Note the drainage issues and trail erosion on the main trail as well as the non-motorized trail where they cross the old slump feature.

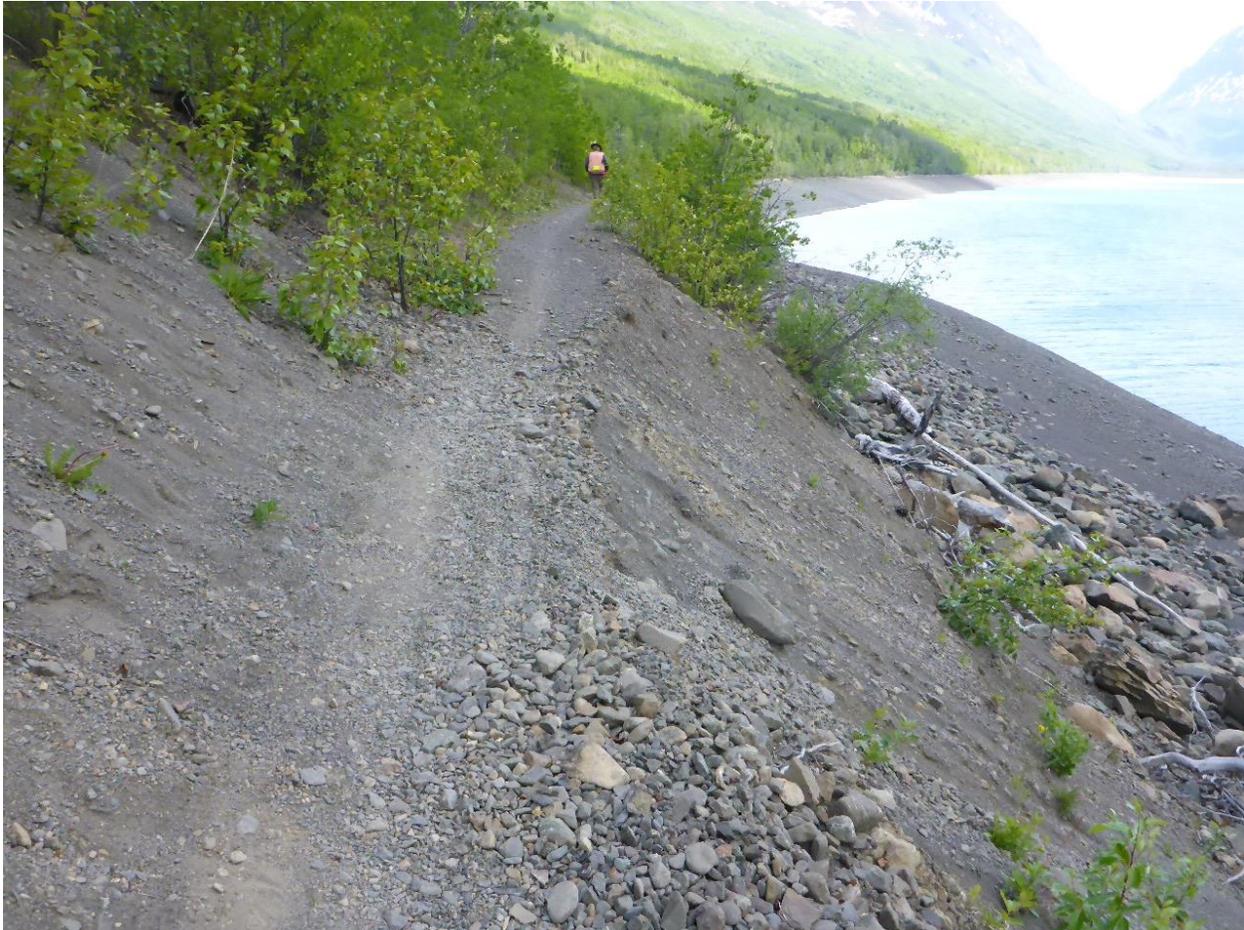
Figure 5.4-6. Erosion site E22.

Erosion site E22 is located on the eastern edge of the Bold Creek alluvial fan. The Bold Creek fan is a complex fan with many terraces and old lakeshores that likely started developing in the late Pleistocene as the Eklutna Glacier retreated up the valley following the last glacial maximum (Figure 5.4-5). There is evidence of several higher lakeshores on the Bold Creek fan and on the Eklutna valley walls in the LiDAR data suggesting a much larger lake filled the Eklutna valley, possibly dammed by a moraine or outwash deposits farther down the valley than the present Eklutna Hydroelectric Project dam. Erosion site E22 is located at the base of one of the alluvial fan features that is the steep edge of an older terrace composed of loose cobble, gravel, and sand. These loose deposits are ravelling down the steep slope uphill from the trail as well as down the bank to the current lake level (Figure 5.4-6). This area is sparsely vegetated due to the well-drained nature of the deposits. Wave action at the base of the bank contributes to erosion at this site. The trail is very narrow at one location, which combined with the loose rocks makes it

difficult to negotiate. Erosion control or a sign warning users of the narrow conditions would be beneficial at this location.

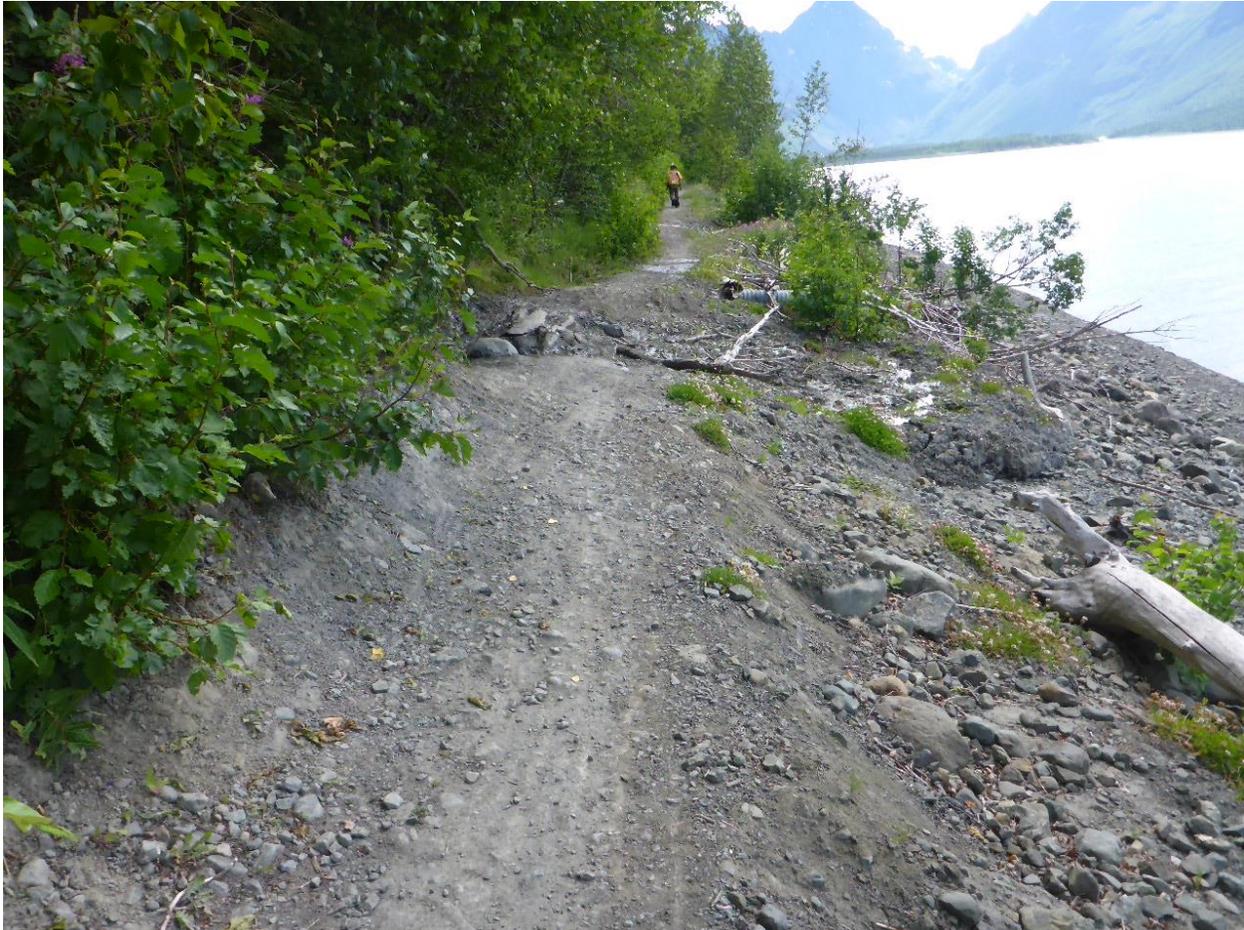
Erosion site E27 includes several blocked culverts, seeps, slumps, and earthflows (Figure 5.4-7). In addition, wave action at the base of the bank has caused erosion of the bank and narrowing of the trail. Maintaining the drainage structures and ditchline would improve the trail conditions and reduced slumps, earthflows, and saturated soil conditions. Erosion control at the base of the bank or signs warning of narrow trail conditions in areas with narrow trail conditions would make the trail safer for users.

Figure 5.4-7. Example drainage issues at Erosion site E27.

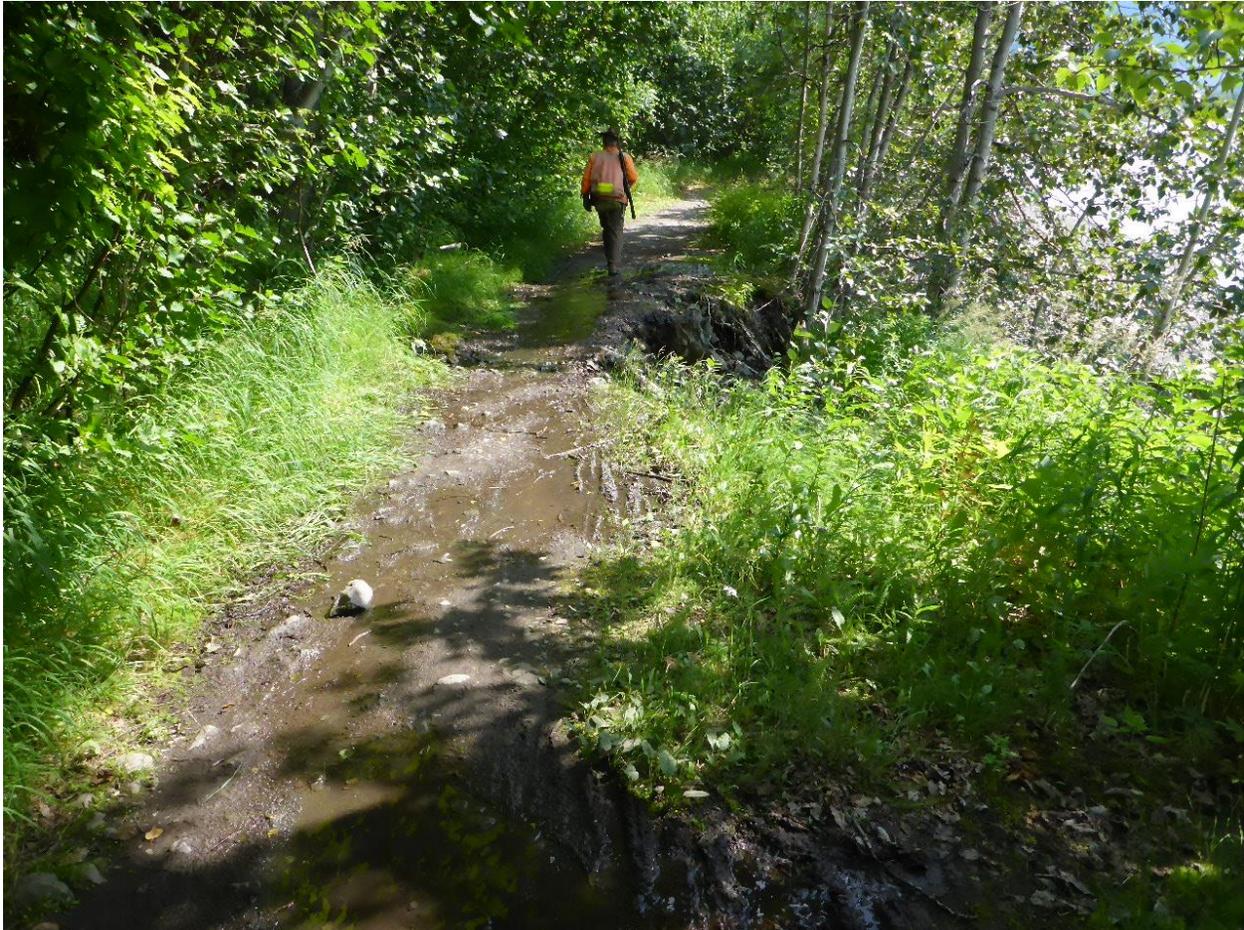
Figure 5.4-8. Erosion Site E36.

Erosion site E36 is a short section of trail (140 feet) with seeps and drainage issues that result in saturated soils and slumps, narrowing the trail and making it difficult to cross the top of the slump (Figure 5.4-8). Wave action is a minor contributor to the erosion at this site, but waves at high lake levels do remove slumped material. Drainage improvements such as maintaining a ditch and installing a culvert could help reduce the potential for future slumping at this location.
