Eklutna Hydroelectric Project

Lakeside Trail Erosion Study

Study Report

Prepared by:
Kathy Vanderwal Dubé
Watershed GeoDynamics

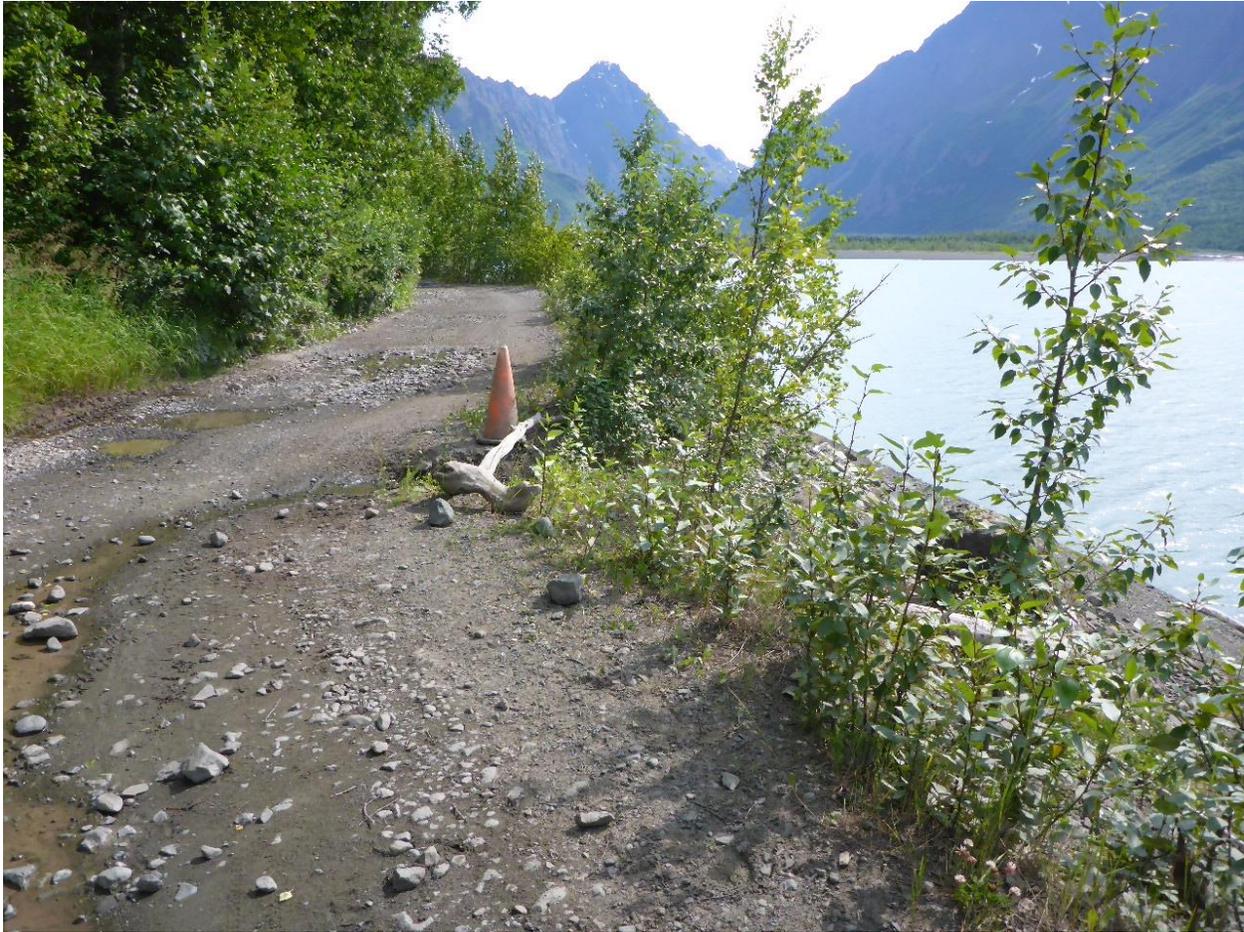
Figure 5.4-9. Erosion Site E38.

Erosion Site E38 includes seeps and runoff from a steep section of trail that result in a saturated trail bed and rills down the bank at several locations (Figure 5.4-9). Two culverts in this segment are plugged, and two additional culverts at small stream crossings south of this segment have high plug potentials and should be maintained to optimize drainage. In addition, wave action along this section has eroded the bank resulting in a 10- to 15-foot-high undercut bank. Keeping the culverts clean and controlling the trail runoff with a drivable dip would improve trail conditions.

E38	Main Trail	Undercut bank/ Rills/ gullies (run off @a few spots)	Glacial deposits	Road Fill	Y	366	10-15	110 UCB	N/A	2-3	0	0	N	N	Riparian Veg/ Trail	Cottonwood	OK	1-20+
E39	Side Trail	Undercut bank/ Slumping, Rills/ gullies (from plugged culverts/ seepage)	Glacial deposits	Road Fill	Y	190	5-7	90 UCB	N/A	2 feet root exposure plus tension cracks	0	0	Y - in places	N	Riparian Veg/ Trail	Cottonwood	Good	5-20
E40	Side Trail	Undercut bank	Glacial deposits	Road Fill	Y in spots	185	5-7	90 UCB	N/A	2-3	0	0	Y	N - active in spots	Riparian Veg/ Trail	Cottonwood/ Spruce	Ok	5-20+
E40a	Side Trail	Undercut bank	Glacial deposits	Road Fill	Y in spots	110	5-7	90 UCB	N/A	2-3	0	0	Y	N - active in spots	Riparian Veg/ Trail	Cottonwood/ Spruce	Ok	5-20+

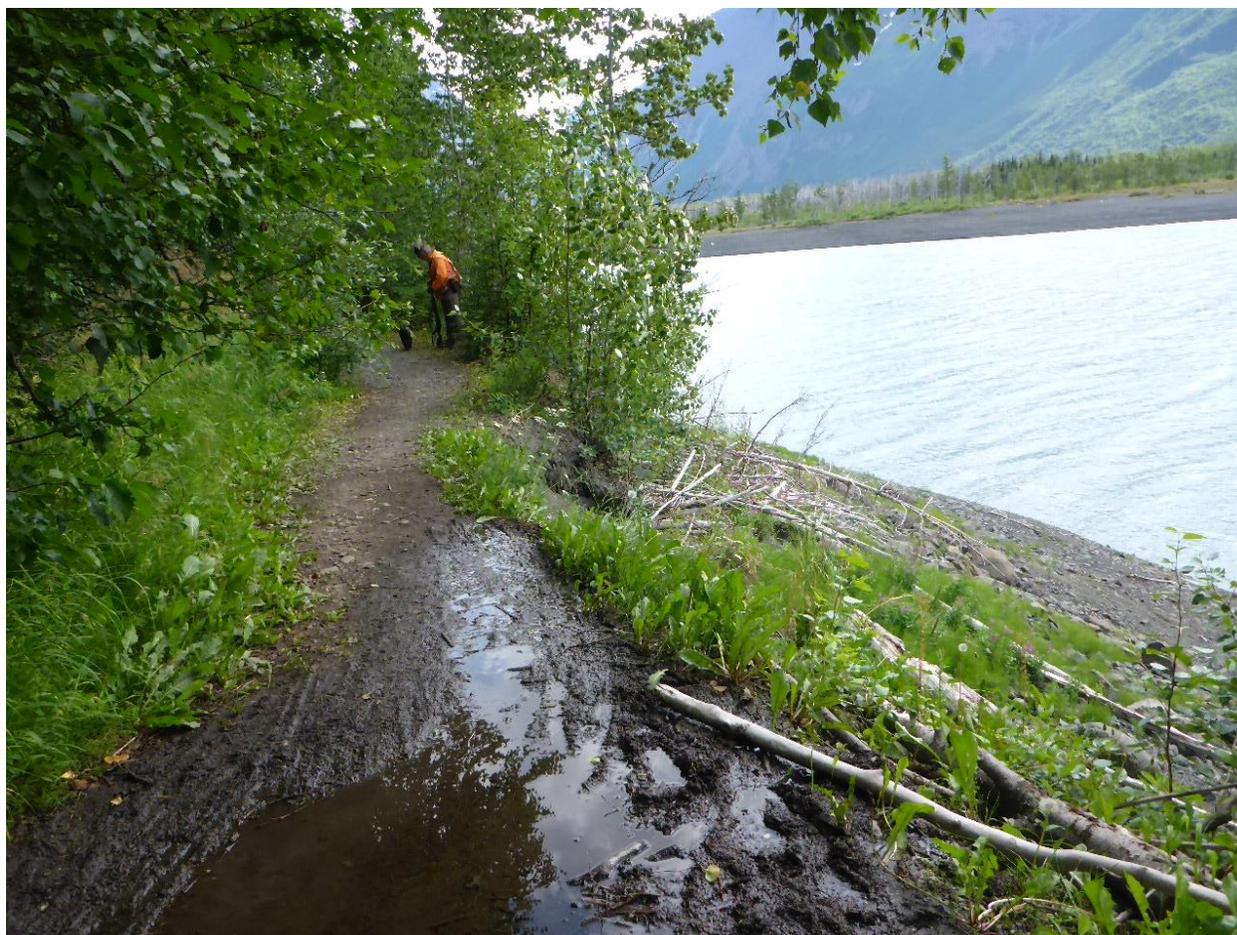
Figure 5.4-10. Erosion site E40.

Erosion Sites E40 and E40a are affected by seepage that causes saturated soils along the trail in a few locations and wave action that has eroded the bank and narrowed the trail in several spots (Figure 5.4-10). The bank at these sites are 5 to 7 feet high and the trail is not narrow enough to pose a major safety hazard but maintaining the culvert and controlling the seeps by installing drainage structures would improve trail conditions.
