Eklutna Hydroelectric Project

Lakeside Trail Erosion Study

Study Report

Prepared by:
Kathy Vanderwal Dubé
Watershed GeoDynamics

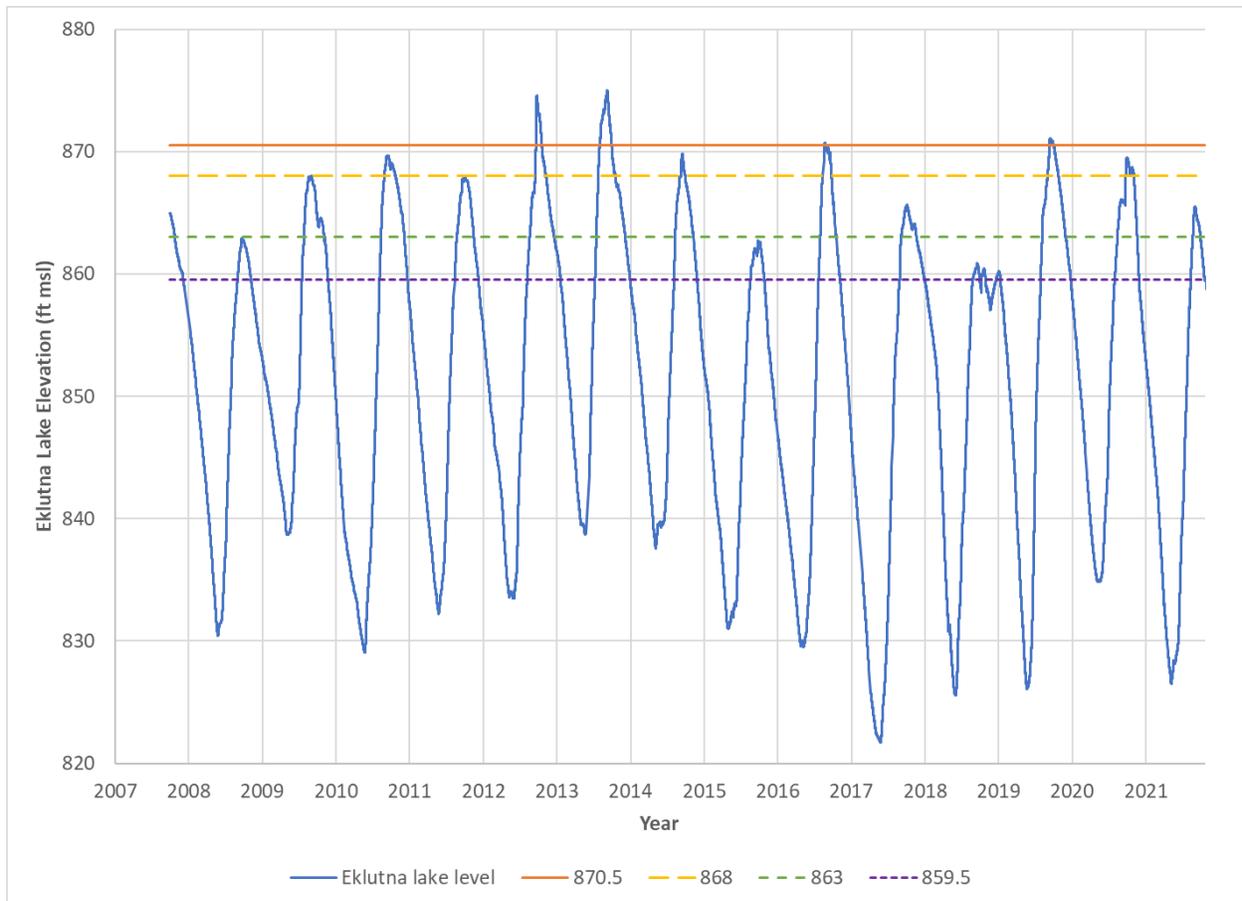
Typical operation of the Eklutna Hydroelectric Project results in seasonal variations in Eklutna lake levels with lowest levels in spring as more water is used than flows into the lake during the winter and highest levels in fall (September) as the lakefills with spring and summer inflow (Figure 6.2-7). Project operational goals include minimizing spill which occurs above elevation 871 feet (USGS gage datum NGVD29). Wave energy on the lake shoreline occurs near the elevation of the lake surface, so the vertical location of erosion is dependent the length of time the water is at a given elevation. Comparing the elevations for the base of the bank and wave-cut benches with the record of Eklutna Lake water levels (Figure 5.2-7 and 5.2-8), the base of the bluffs (870.5 feet) corresponds to an elevation just below the spillway crest. In the past 14 years the highest lake elevation occurred in the fall of 2012 and 2013 (note that the highest lake elevation on records occurred in 1995 when the lake rose to 877.6 feet). ADNR staff report that high winds during the 2012 and 2013 high lake level periods resulted in substantial erosion along the lakeside trail.

Figure 5.2-7. Eklutna Lake water surface elevation, 2007-2021 and elevations of prominent wave-cut terraces within the lake.

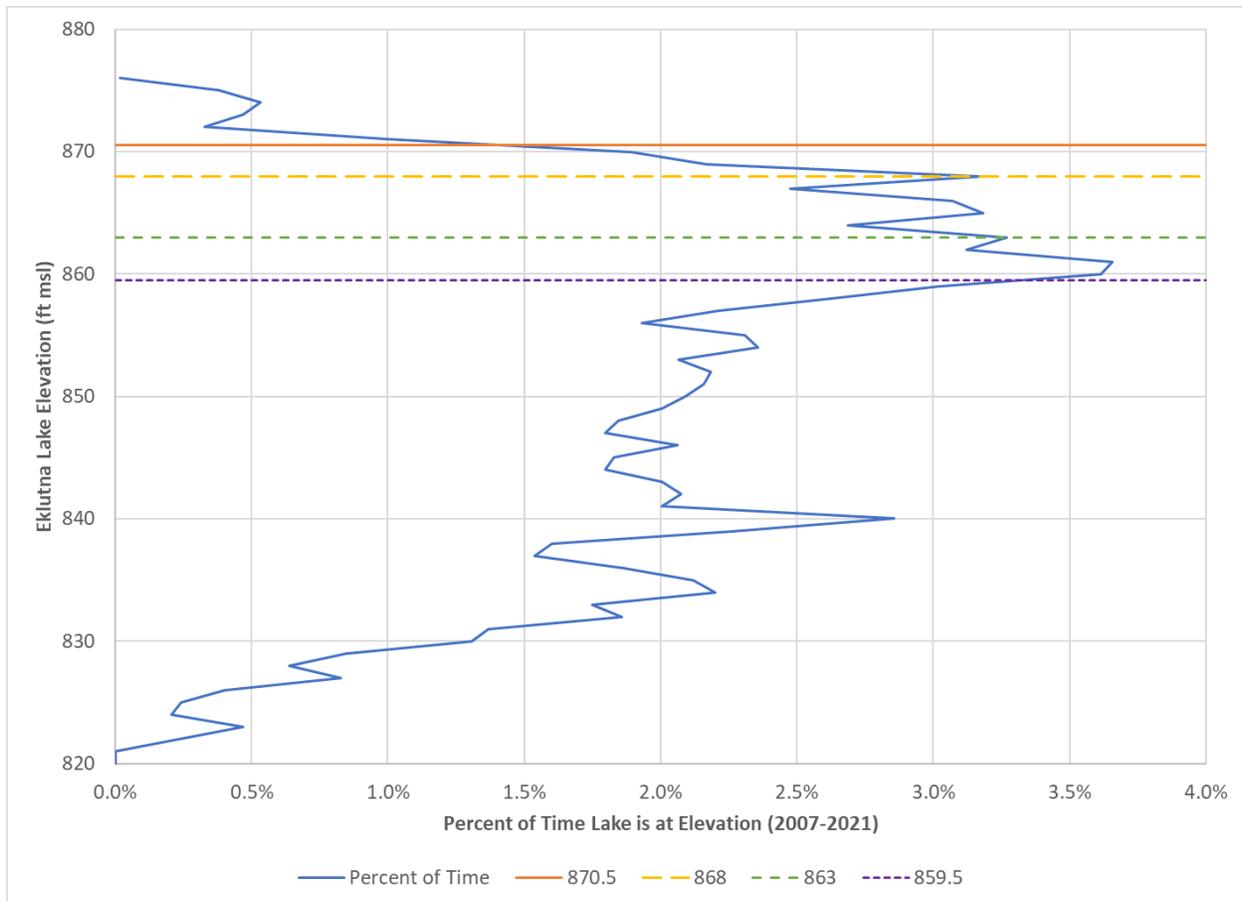
The prominent wave cut bench at elevation 868 corresponds to the highest lake elevation that is frequently reached (Figure 5.2-8). Other prominent benches at approximately elevation 863 and 889.5 likely correspond to other frequent lake elevation levels.

Figure 5.2-8. Percent of time Eklutna Lake water surface was at a given elevation, 2007-2021 and elevations of prominent wave-cut terraces within the lake.

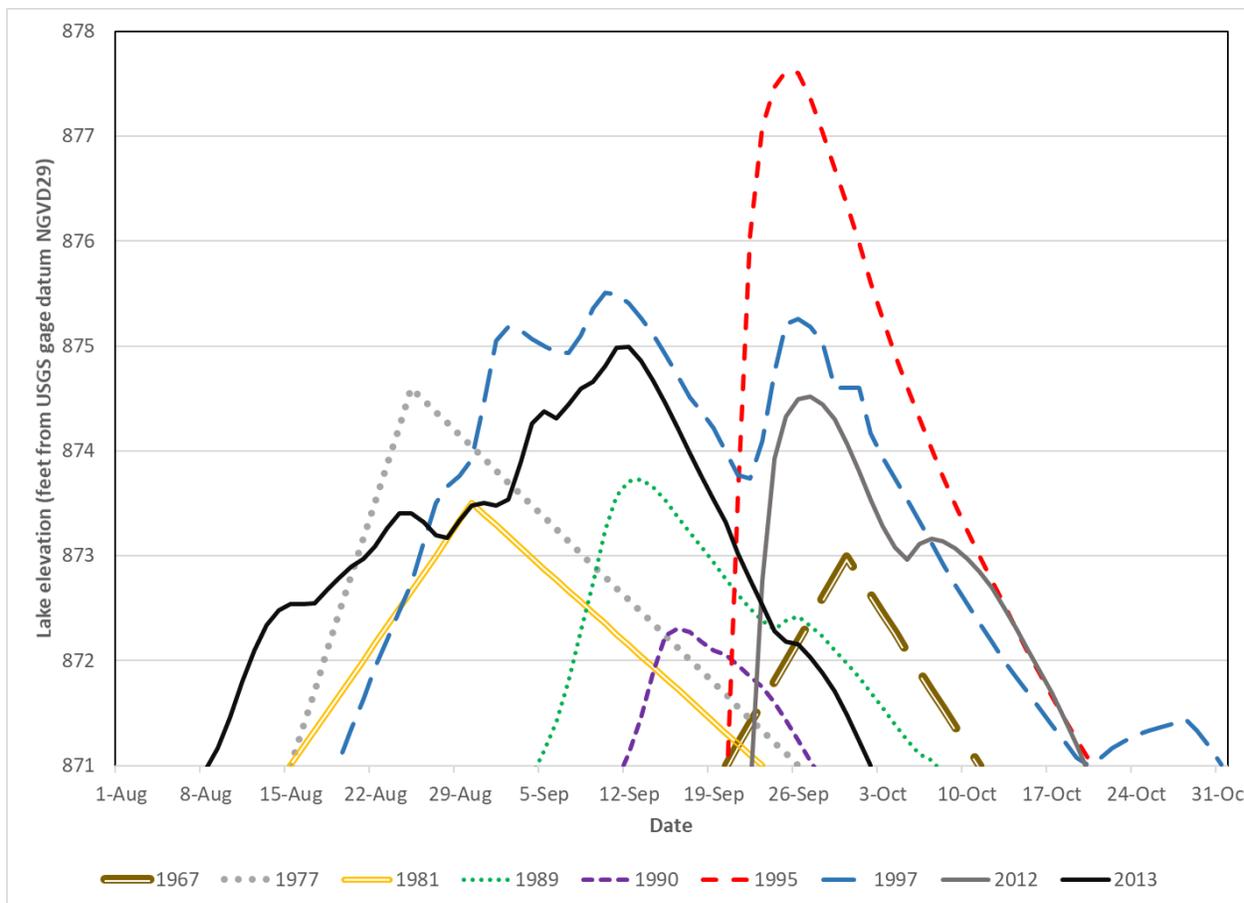
Based on reports from ADNR staff, it appears that most shoreline erosion occurs when the lake is at elevations at and above the spillway elevation (871 feet) depending on the height and swash zone of the waves during the period of high lake levels. Under the current operational regime, the lake exceeds elevation 871 feet less than 2 percent of the time (based on 2007-2021 period). Lake elevations above 871 feet occurred in 9 years since 1965 (MJA 2020, Figure 5.2.9). The effects of any future modifications to Project operations that change lake elevations will be analyzed as part of effects analysis.

Figure 5.2-9. Lake elevations during spill events at Eklutna Dam from 1965 to 2019 (MJA 2020).

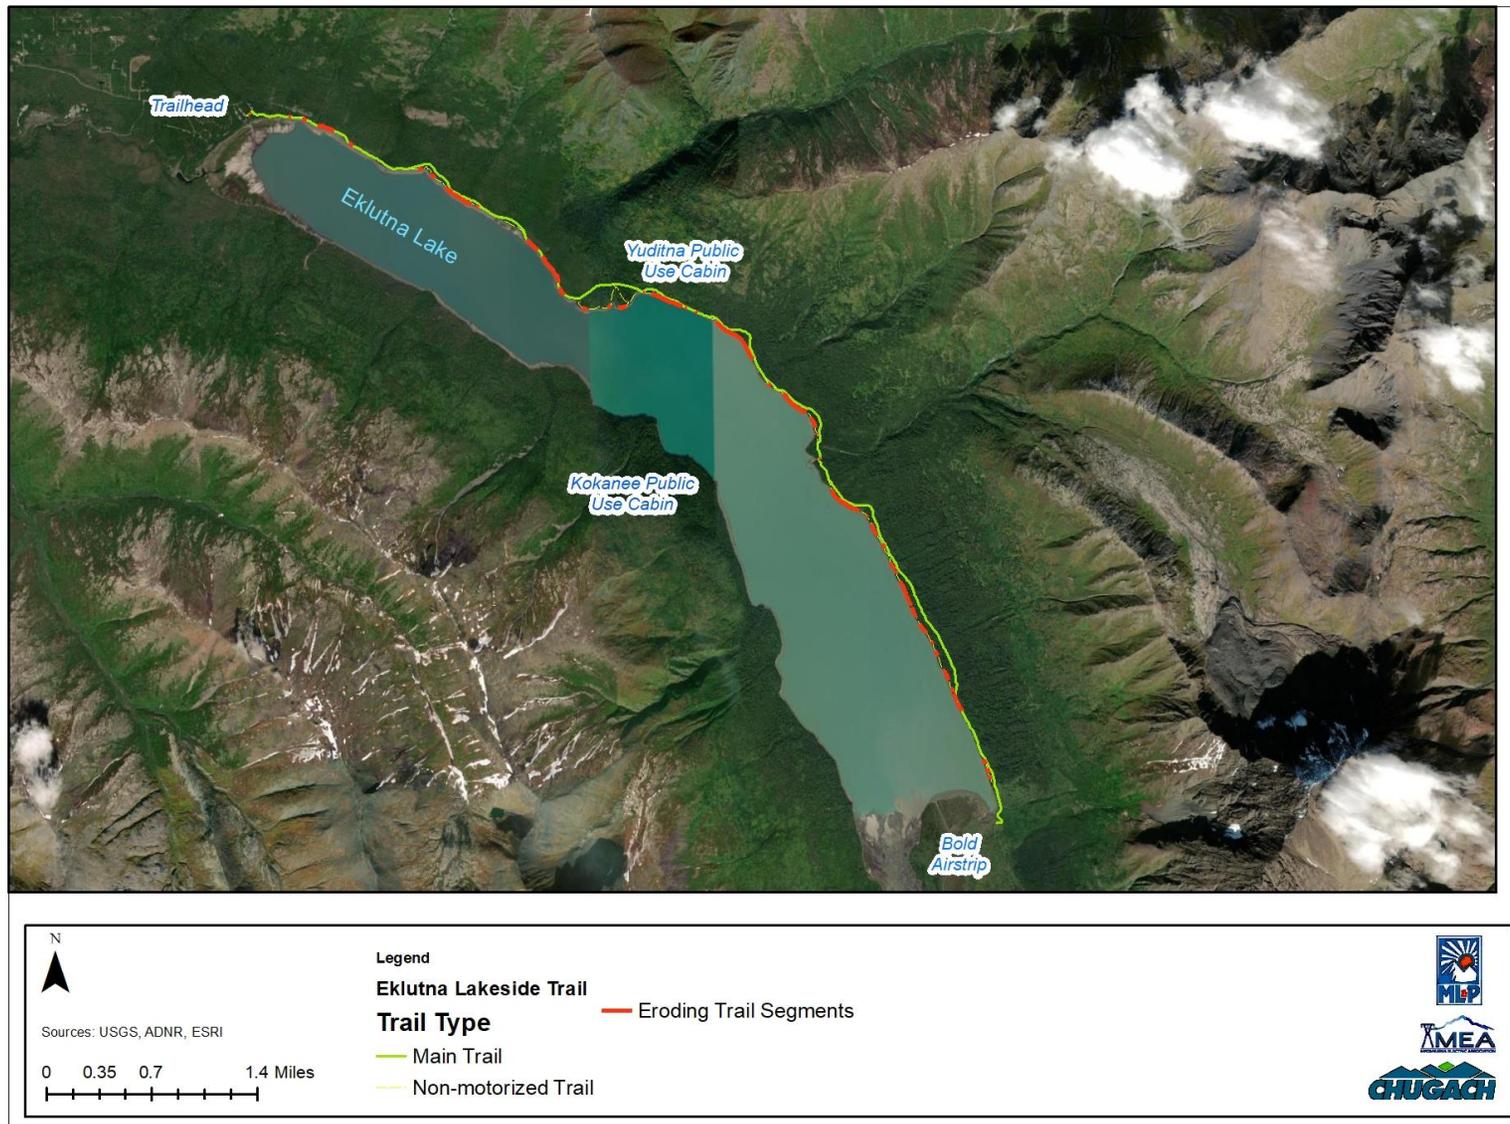
A total of 59 eroding areas were delineated along the lake shoreline portion of the Eklutna Lakeside Trail, including areas showing past and/or more recent erosion (Figure 5.3-1, Appendix 2 and Appendix 3). The inventory followed the pathway closest to the lake and included 2.7 miles of main trail and 4.9 miles of non-motorized trail (side trail). Shoreline erosion was noted along 0.6 miles of the main trail; 2.4 miles of the non-motorized trail had shoreline erosion.

The factors contributing to erosion were recorded at each site; many sites had multiple factors. All lakeshore erosion sites had wave action at high lake levels as one of the factors contributing to erosion. Seepage and runoff were the second most common factor, present at 28 percent of the sites (by length) and blocked culverts were listed at 9 percent of the sites. Reservoir

fluctuations was listed at 28 percent of the sites. Pedestrian use (19 percent of the sites) and raveling of steep cutslopes (8 percent) were the remaining factors affecting erosion.

Figure 5.3-1. Shoreline erosion along the Eklutna Lakeside Trail.

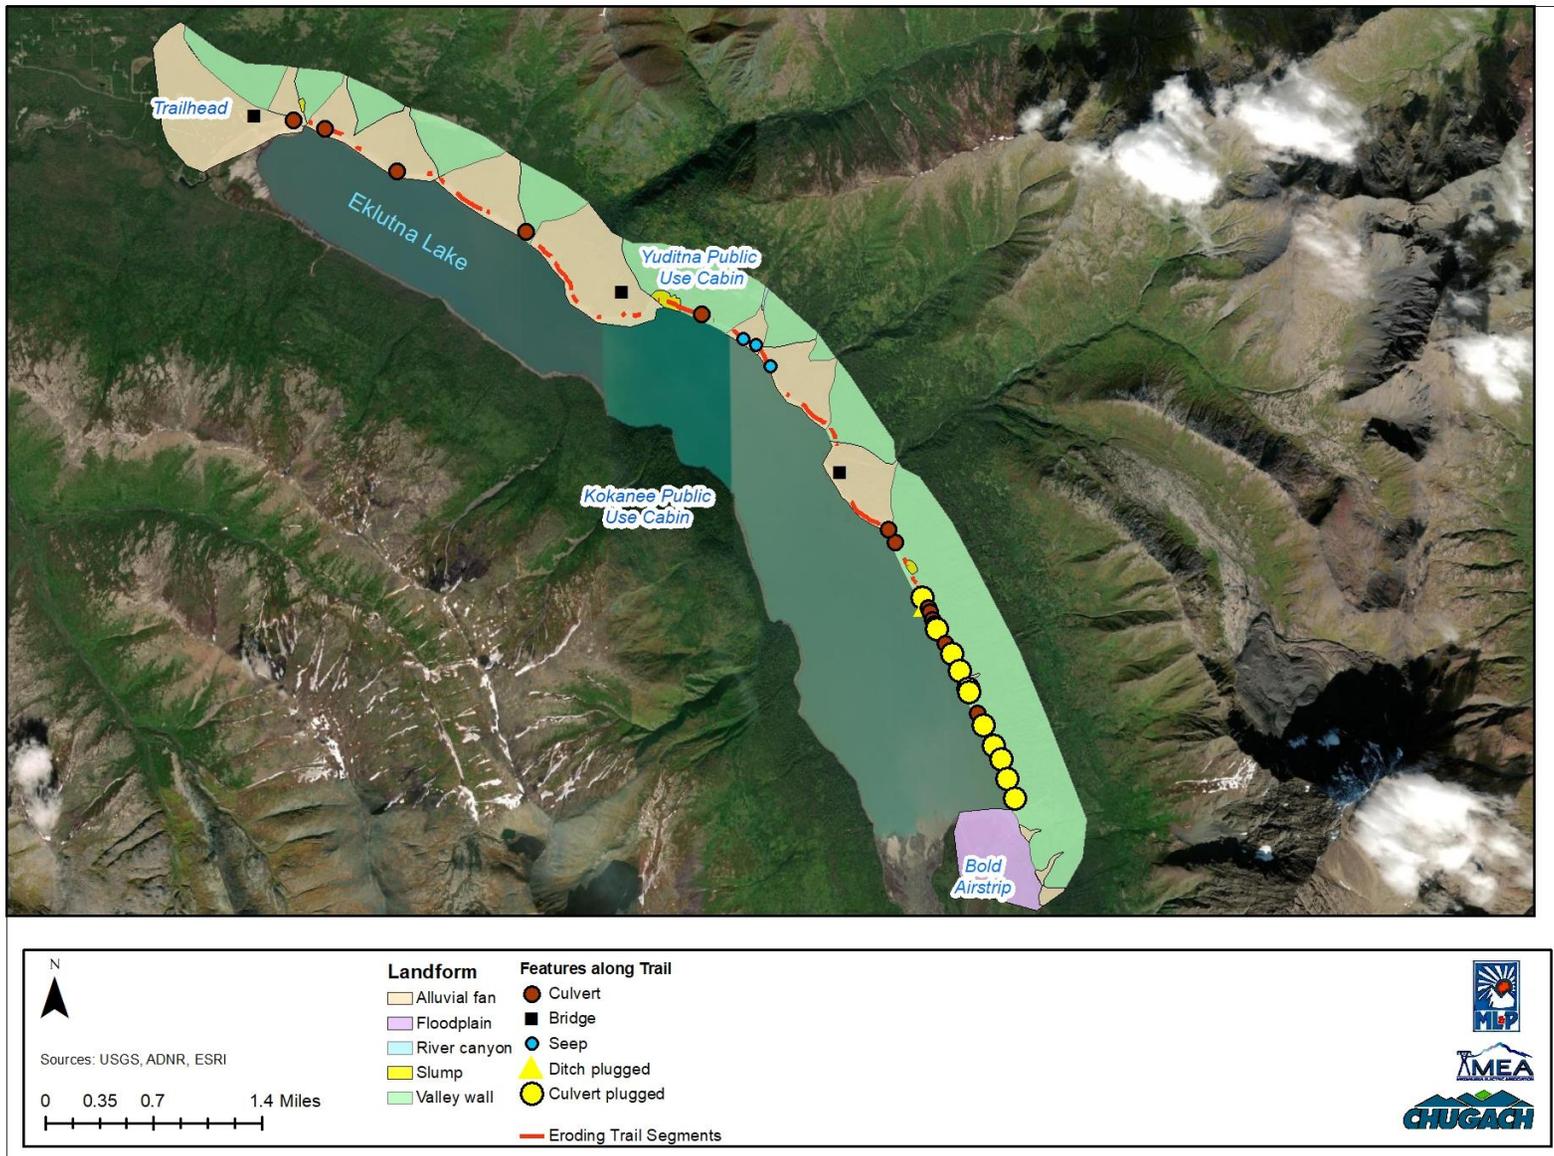
The Eklutna Lakeshore Trail is constructed on three main landforms: alluvial fan (64 percent of trail length); valley wall (32 percent of length); and a small area of past slumping (4 percent of length, Figure 5.3-2). Wind waves are the primary factor contributing to erosion at erosion sites on alluvial fans, with erosion on the parts of the fans that face either up- or down-lake where wind have the longest fetch resulting in higher waves.

Figure 5.3-2. Eklutna Lakeshore Trail erosion, culverts, drainage issues, and landforms.

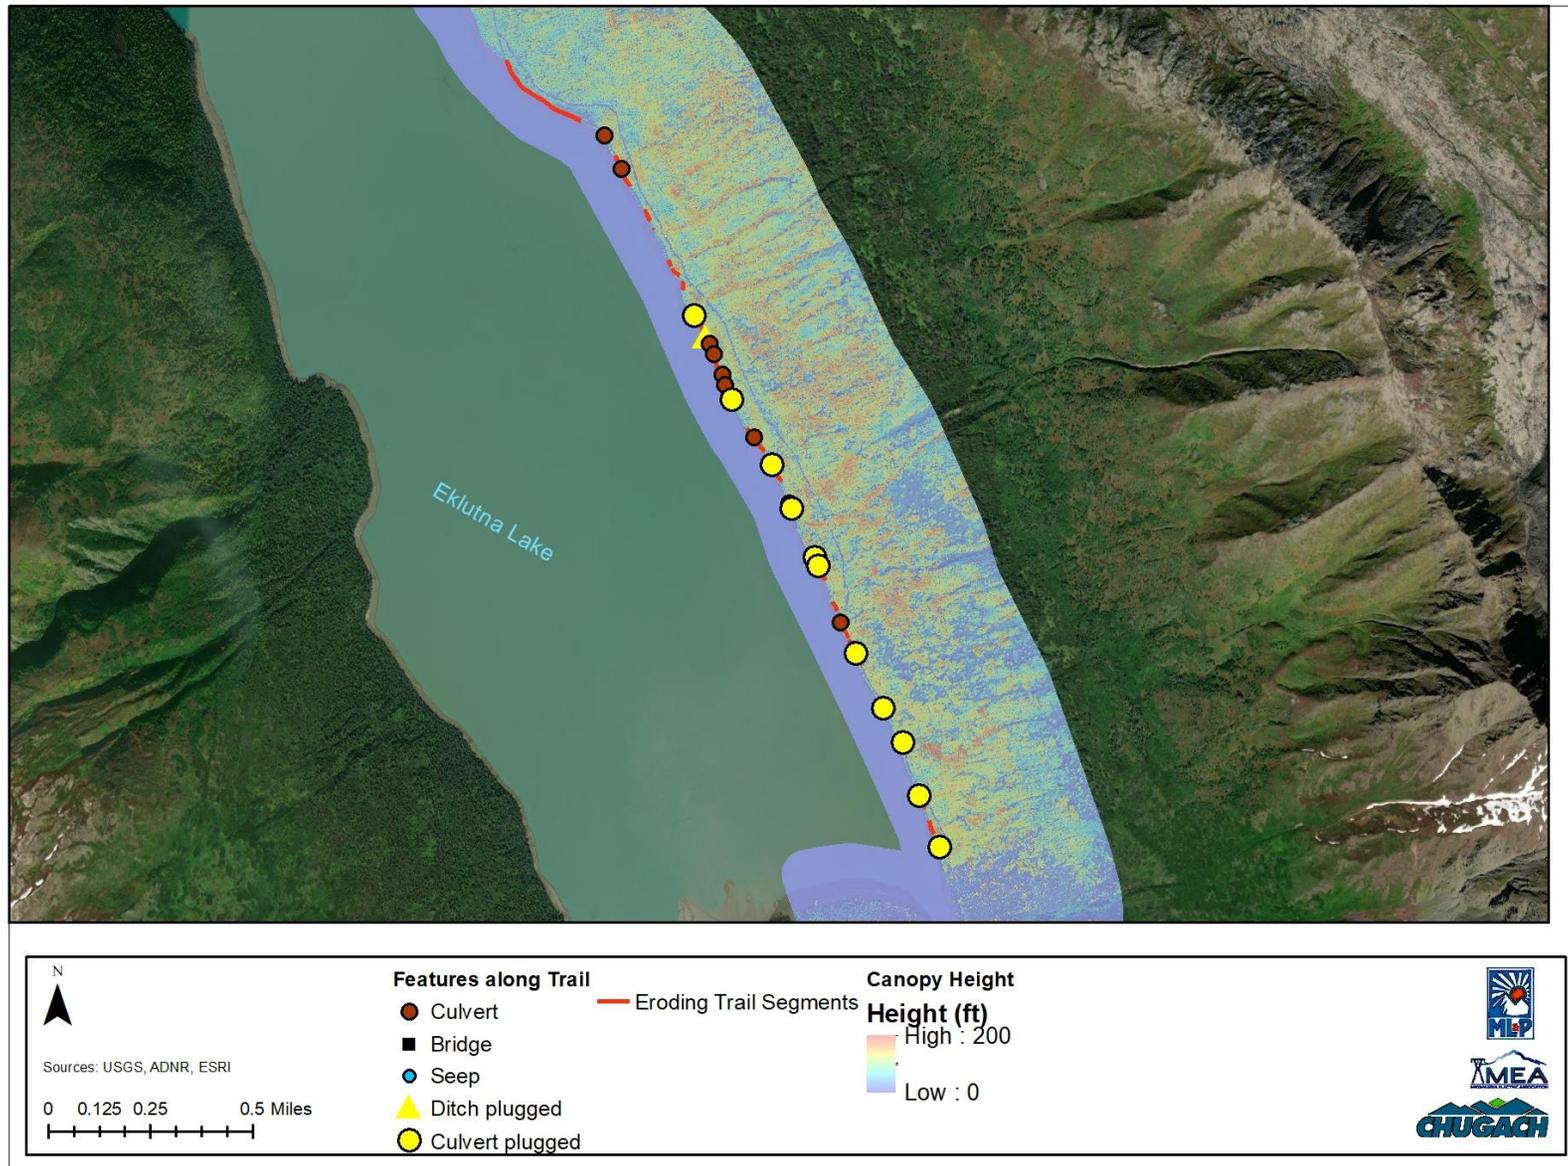
Erosion areas on valley wall landforms have seepage and drainage issues contributing to erosion and do not appear to be correlated with length of wind fetch although wave action is contributing to erosion at all sites. Drainage issues are most pronounced along the southeastern third of the trail where seepage, plugged culverts, filled ditches, and lack of drainage structures occur frequently. This section of trail follows the valley wall and is underlain by glacial deposits. Overlaying the canopy height (derived from the 2020 LiDAR first hit and bare earth layers) with the drainage and erosion sites shows that areas with taller trees mark places where drainage issues are most prevalent, likely indicating water courses or shallow groundwater that contribute to taller tree growth (Figure 5.3-3).

Figure 5.3-3. Southeastern section of Eklutna Lakeside Trail with drainage issues and canopy height.

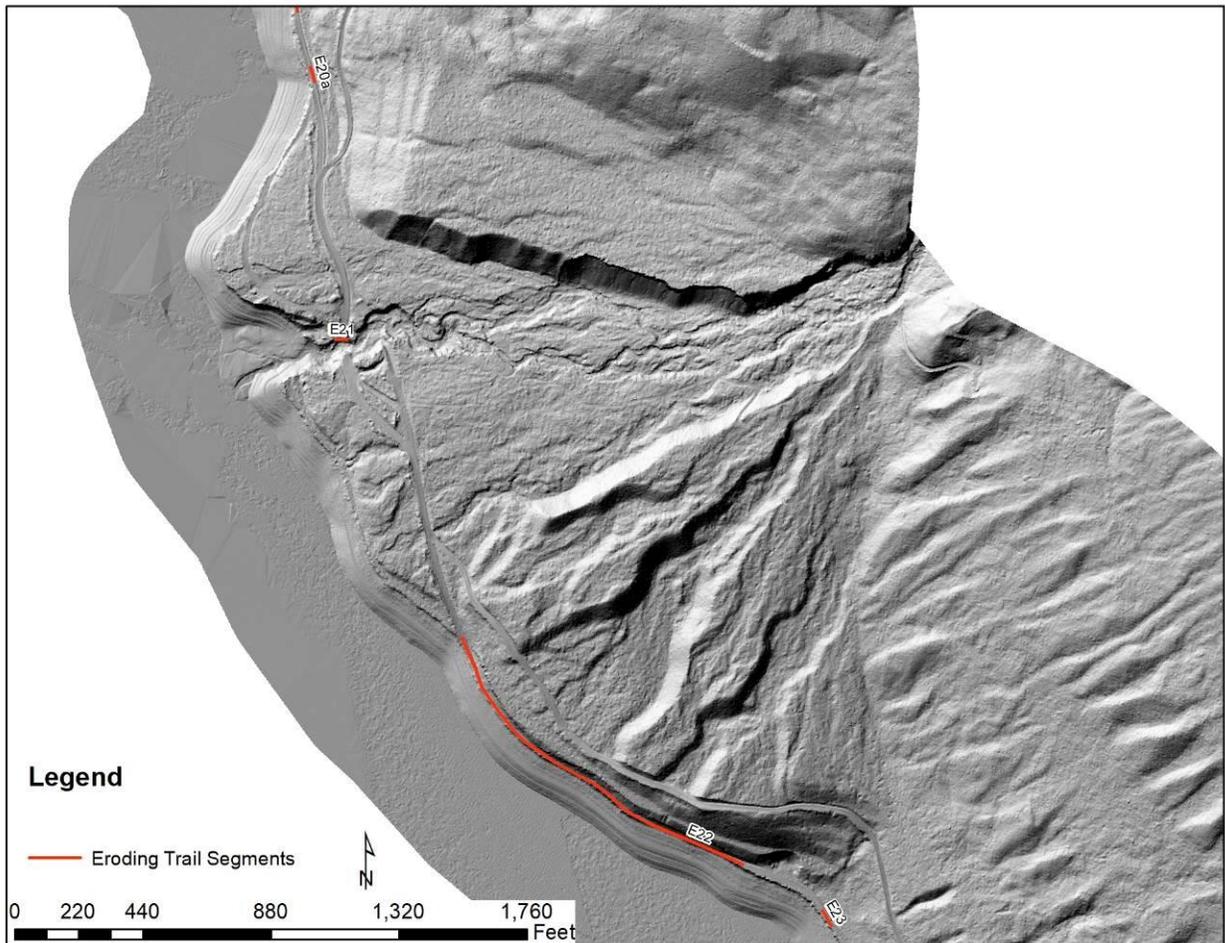
Figure 5.4-5. Bold Creek alluvial fan showing multiple higher lake shorelines and Erosion site E22.

difficult to negotiate. Erosion control or a sign warning users of the narrow conditions would be beneficial at this location.
